## PFR-015

### Title: Bearing Failure of Release Ring on SPB

<b>Assembly :</b> SPB, S/N 906	<b>SubAssembly :</b> Release Ring Assy
<b>Component :</b> Inner Bearing, Dynaroll Part <b>Number:</b> SR144ZZMC3 3GM6	
<b>Originator:</b> B. Donakowski/ 05 FEB 05	<b>Organization:</b> UCB/SSL/EFI
<b>Phone :</b> 510.642.9050	<b>Email :</b> billd@ssl.berkeley.edu

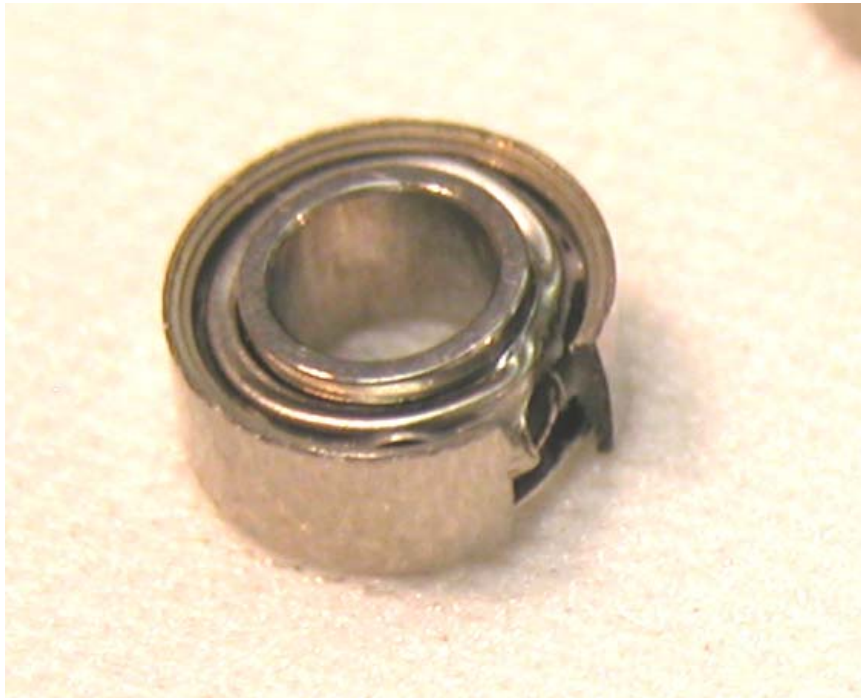
Following Vibration and TVAC, it was noticed in inspection that an inner bearing was cracked. This bearing is a part of the Release Ring Assy which opens the SPB Front Cover. The crack was on the outside race. (See Pictures 1 and 2.)

Picture 1: Bearing Failure, Part number SR144ZZMC3 3GM6 (Inner Bearing of Assembly)

1. Verify circularity of all pins prior to installation.
2. Provide proper press fit tooling to technicians to ensure proper installation.
3. Use spacers on either side of bearings to make sure press is made to inner race only.
4. For all SPB units, remove and replace subject bearings with new bearings and pins using custom press tooling. Verify all bearings are free to turn following rework. See Tech Memo 2005-PFR-015 for complete rework procedures (attached to this PFR).

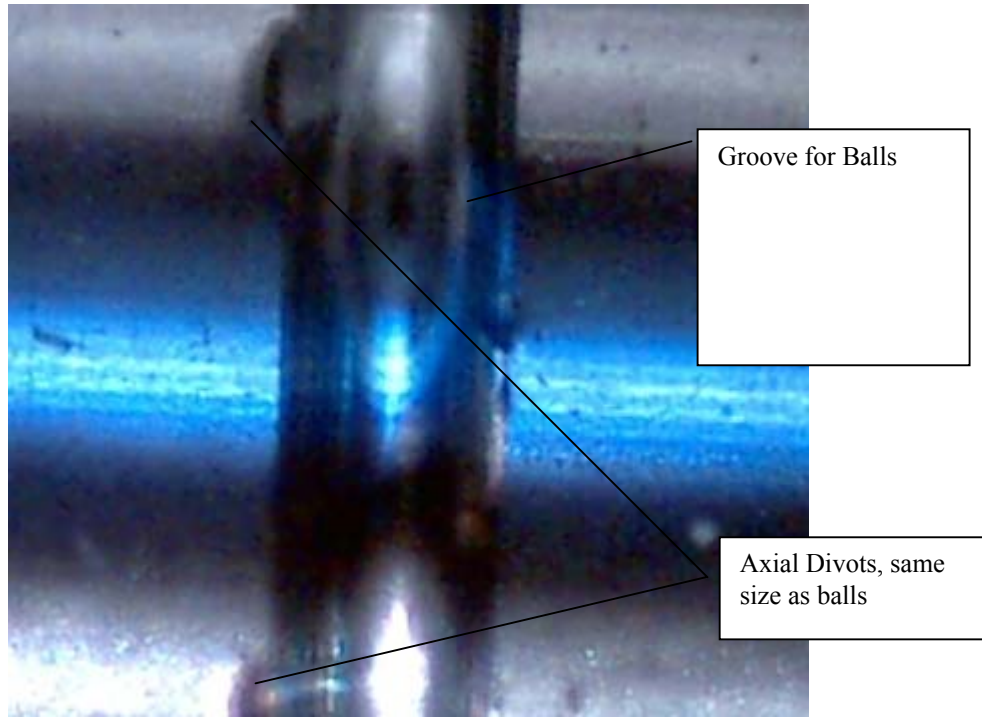
Dynaroll Technical Rep (Dave Cook) came on-site to inspect subject part. His opinion was that the bearing was well below its thermal and static capability in our application (verified by UCB). On taking the bearing apart, it was obvious some divots had been formed on the OD of the inner race which were obviously caused by the balls being dragged in an axial direction. As the bearing receives almost no load in axial, and the only loading occurred axially during installation, it is believed the bearing was damaged during installation. On these units, the release ring assy had been put together incorrectly (incorrect lengths shafts first installed). The removal and replacement of the bearings on the axles was required to put the assy in the flight configuration. Removal and replacement of bearings may have been a possible cause of this failure, though it is not known if the original bearings had been re-used on the rebuild. On further investigation, it was noted the shafts (new, unused ones still in the bag) for the assy were out of round, being out of center by a few ten thousandths (visible to the naked eye). An out-of-round axle would induce further loading during installation.

Picture 2: Divots around center groove of OD of Inner Race

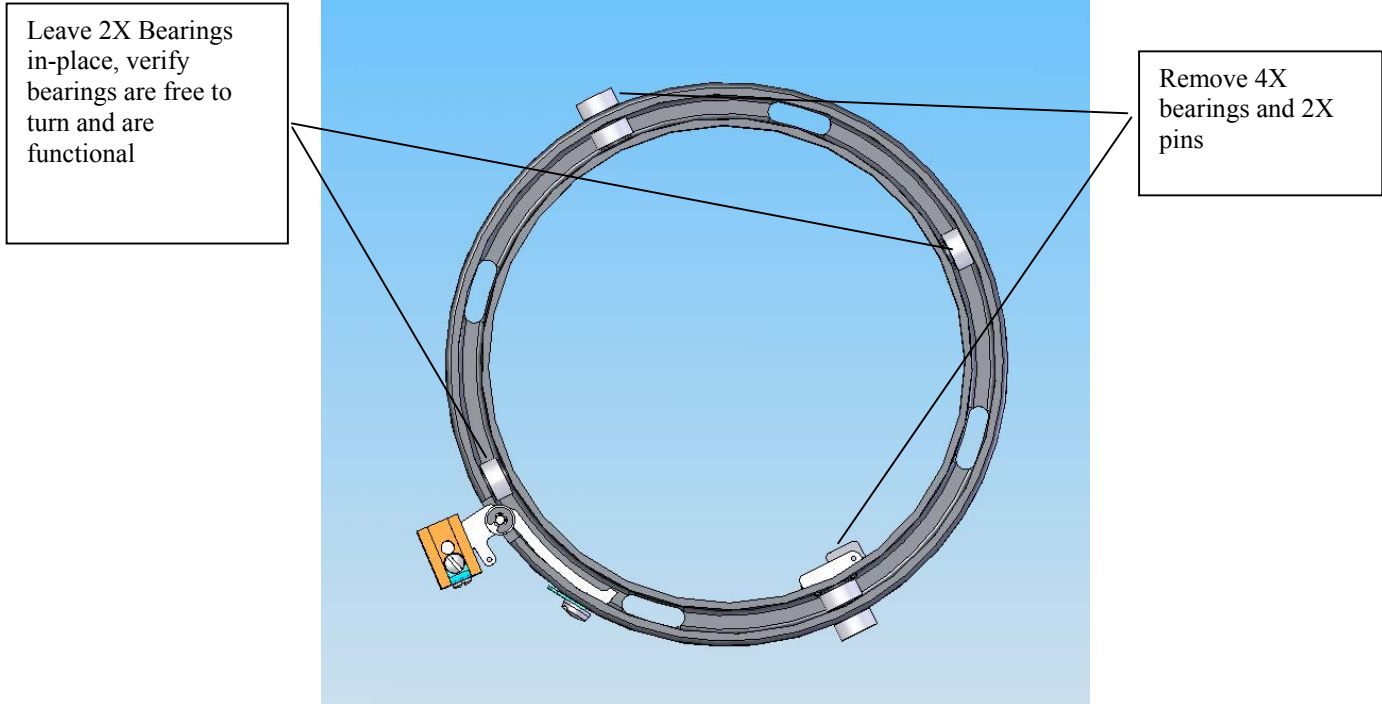
Figure 1: Bearing Removal

1. Carefully remove 2 X pins (.125 DIA X .375" Lg) and 4X Bearings by pressing out using special bearing removal tool. Keep all removed parts segregated and labeled so as not to be confused with new. See Figure 1 for bearing locations.
2. Verify 2X bearings that were left installed are turning properly. Move with finger. (See figure 1.)
3. Inspect holes where pins were removed. Deburr to remove any rough edges or metal bits.
4. Turn down many pins per UCB drawing THM-SPB-MEC-456. This can be done by chucking up pin and slightly removing a few ten thousands of an inch using emery cloth. Verify final dims meet print. Two ends of part shall be denoted 'A' for side with smaller ID (less than .125") and "B" for side with larger ID (.1252, the stock diameter). See Figure 6.

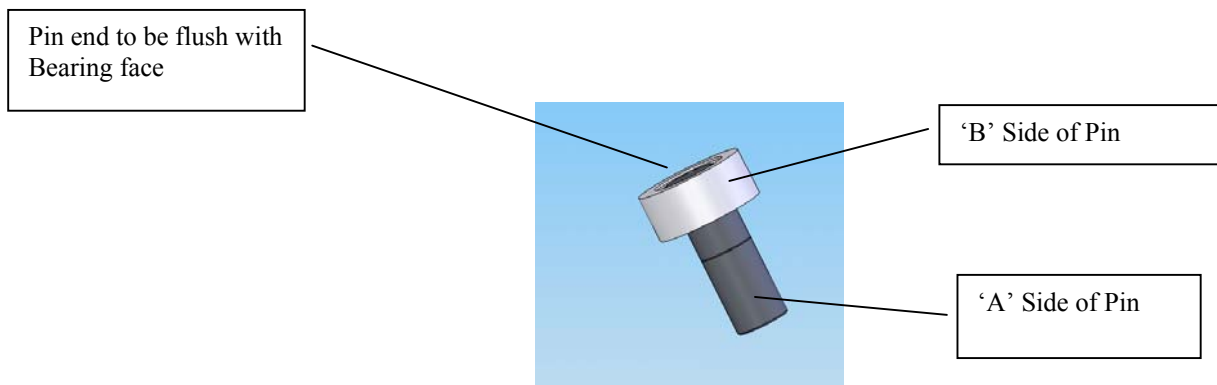
Figure 2: Bearing pressed onto 'B' side of Pin

5. Press one bearing onto the end of the THM-SPB-MEC-456 shaft, side 'B'. (Bearing Part Number Dynaroll # SR144ZZMC3 3GM6.) End of 'B' side of shaft to be flush with end of bearing. Use custom Arbor Press (with canted surface and cylindrical piece) and proper tool end. See Figure 3.
6. Shear Bearing Spacers as shown in Figure 4.
7. Pre-position a bearing into the opening of the Release Ring, line up the centerlines of bearing and ring. Place three spacers as shown in Figure 5. Place the bearing and ring into the press (see figure 3). Using the Axle and pin (from step 5), press Side 'A' thru the ring, the pre-positioned bearing and spacers, and back into the ring flange.
8. Verify 2 X bearings are free to turn, verify pin is completely installed, verify pin is not exceeding ID of Release Ring, verify outside bearing is flush with pin end, verify pin can not pull out of ring easily.

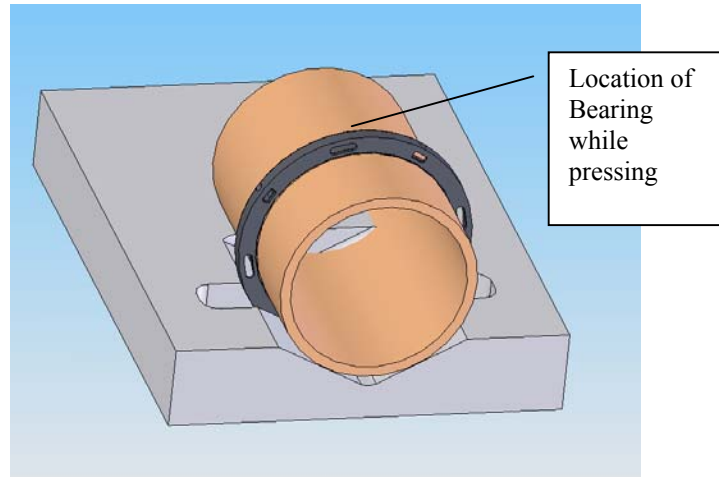
Figure 3: Release Ring shown over Cylinder in Bearing Installation Set-Up

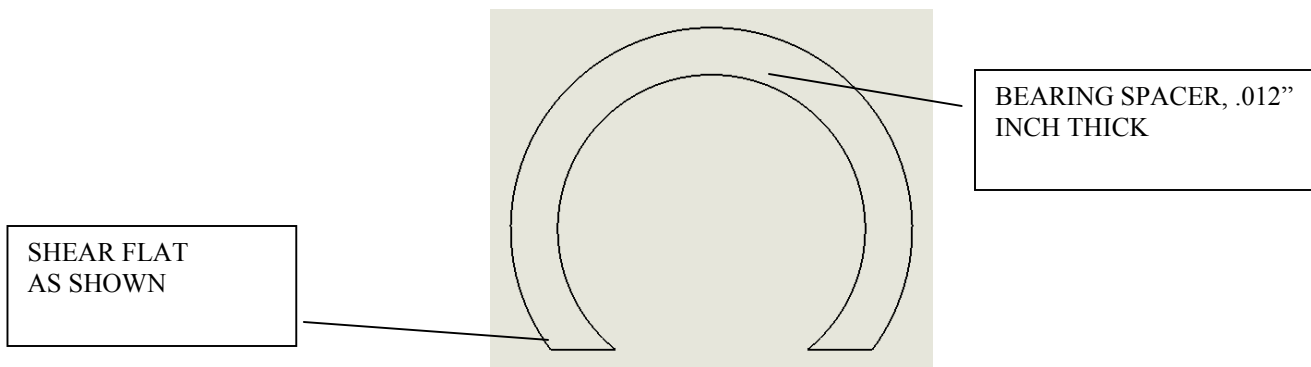
Figure 4: Modification of Bearing Spacer (all units)

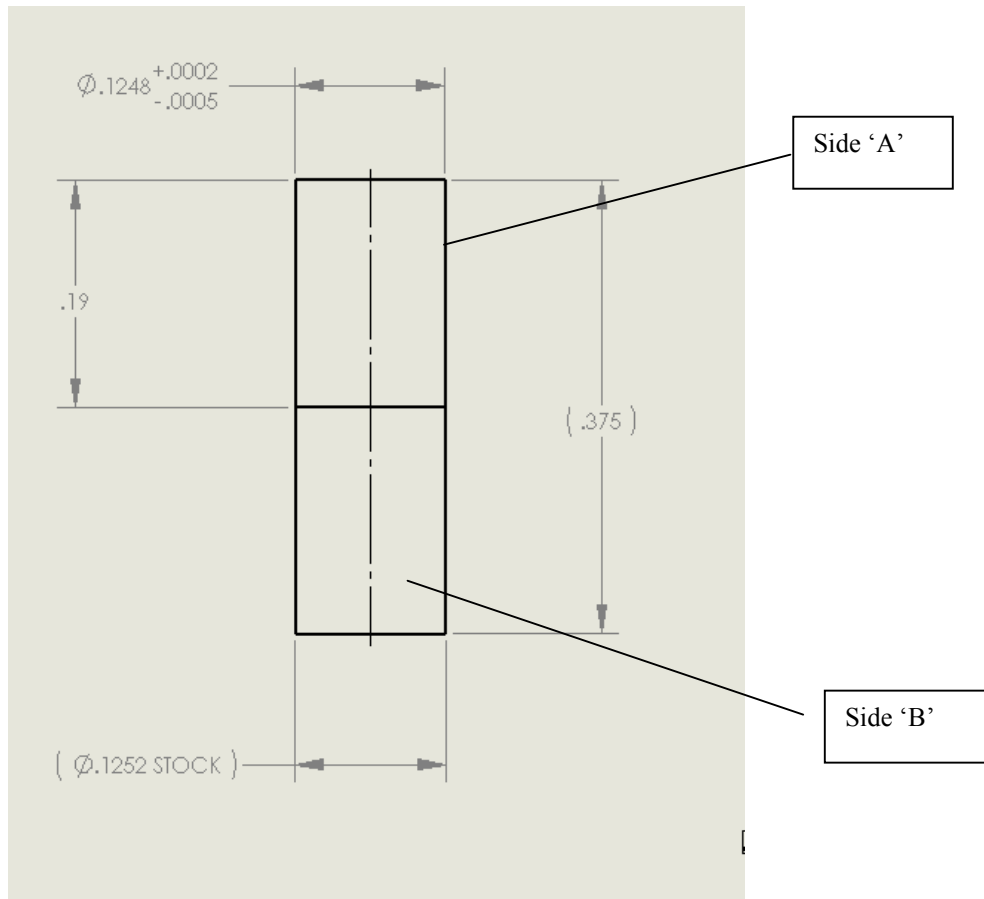
Figure 6: THM-SPB-MEC-456 Pin Detail
