## PFR-020 Title: SPB Sphere Keyreel Axle Modification

<b>Assembly :</b> SPB Assy THM-SPB-MEC-001	<b>SubAssembly :</b> Sphere Keyreel
<b>Component :</b> Keyreel Spring Axle	
<b>Originator:</b> Gregory Dalton	<b>Organization:</b> UCB/SSL THEMIS EFI
<b>Phone :</b> 510.643.9240	<b>Email :</b> gdalton@ssl.berkeley.edu

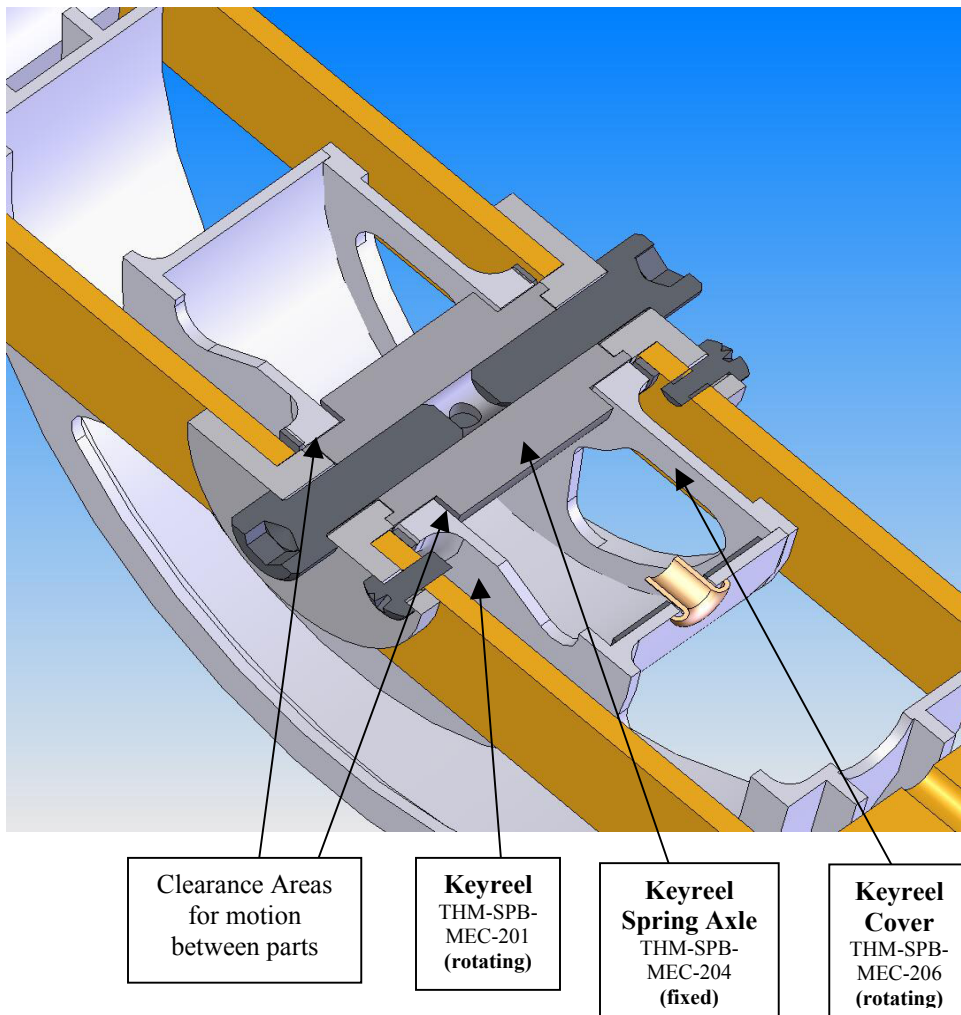
Figure 1. SPB Sphere Keyreel Assembly  
Section Diagram - THM-SPB-MEC-200

The sphere in question was disassembled and all parts checked for excessive or abnormal wear, tolerances per part drawings, material failures, and assembly inconsistencies. Excessive wear was noted in the mating area of the *Keyreel* and *Keyreel Cover* with the *Keyreel Spring Axle* (fig. 1). Plating was rubbed off, and some plating and aluminum material was embedded in the PEEK *Keyreel Spring Axle*. This created friction between moving and stationary parts, exacerbated by CTE mismatches in materials during thermal-vacuum testing. After analyzing the subassembly CAD model and fabrication drawings, it was noted that moving parts did not have sufficient clearance. In addition, dry lubricant was not applied between moving components. After analyzing other tested subassemblies that did not exhibit binding, it was determined that the machined parts were at LMC per original shop drawings, allowing sufficient clearance to avoid failure.

Part drawing dimensions and tolerances were changed. The *Keyreel Spring Axle* was removed and re-machined to create more clearance between the moving *Keyreel* and *Keyreel Cover*. DAG-154 was applied to the *Keyreel Spring Axle* before installation to provide lubricant to the moving parts.

1. All *Keyreel Spring Axles* will be removed and machined per THM-SPB-MEC-204 Rev G to allow for more clearance with other moving parts of the keyreel.
2. Permaslik RMAC will be applied to the *Keyreel Spring Axle* before installation to provide sufficient lubrication between moving parts.
3. Bench test force/deflection data will be analyzed carefully prior to thermal-vacuum testing. This will identify any future problems prior to environmental testing.
