**PFR-022 Title: SPHERE BOSS BACKING OUT OF DOOR RETAINER**

<b>Assembly:</b> SPB Top Assy, THM-SPB-MEC-001	<b>Subassembly :</b> Sphere Sensor, THM-SPB-MEC-200
<b>Component:</b> Sphere, THM-SPB-MEC-208	<b>SPB S/N:</b> 901
<b>Originator:</b> B. Donakowski/ 24FEB05	<b>Organization:</b> UCB/SSL/EFI
<b>Phone:</b> 510.642.9050	<b>Email:</b> billd@ssl.berkeley.edu

## **PFR-022 Sphere Boss Mislocated into Release Door Retainer**

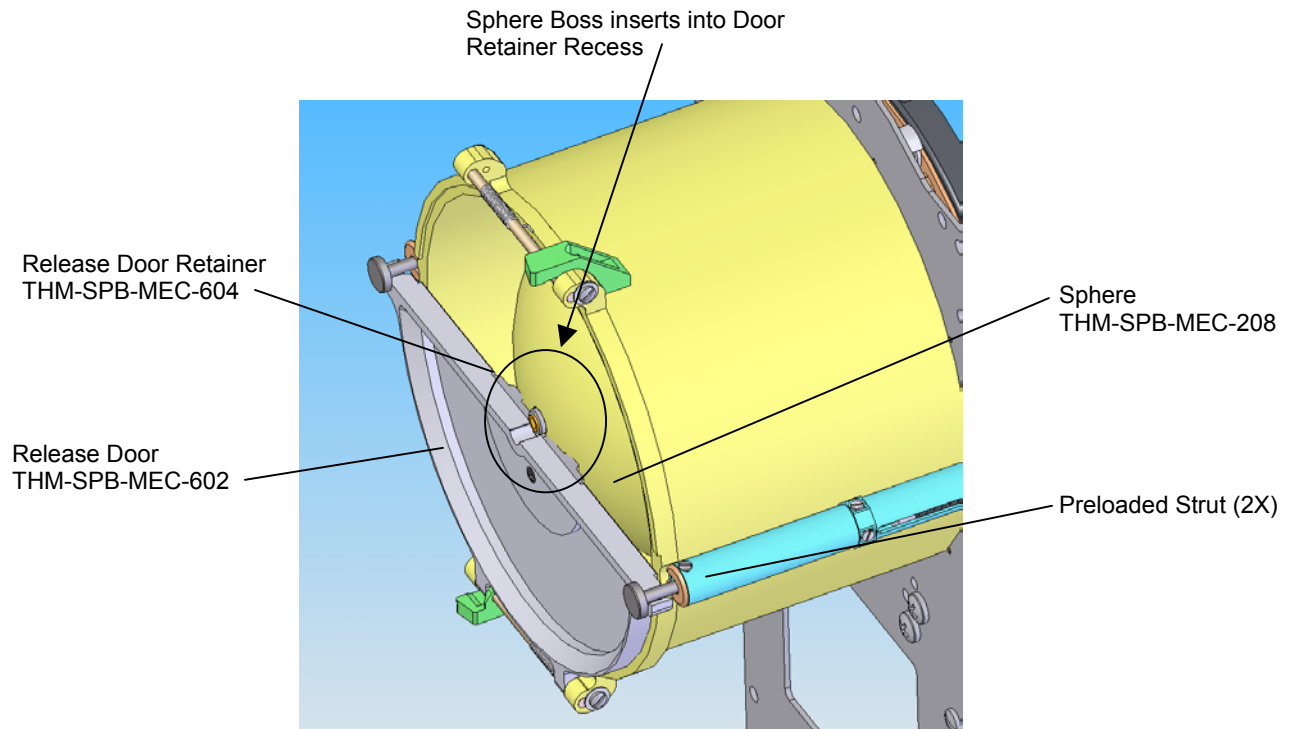
During SPB Electrical Testing in Clean Room 125, it was discovered that the Sphere external boss, which normally engages into the preloaded Release Doors and Door Retainer, had moved to a position in which it was no longer inserted in the recess in the front door. See Figure 1, Sheet 2. The Sphere is held inside the SPB Snout by virtue of the two bosses (180 degree apart from each other) being compressed by the preloaded door. This new boss position would render the Sphere improperly set for vibration as the preload would be ineffective without the Sphere boss firmly set into the Retainer recess.

Figure 1: SolidWorks Model showing Sphere Boss correctly inserted into Recess in Door Retainers (one door removed for clarity).

For this unit, Release Door should be opened, Sphere repositioned, and Release Doors set to preload. For future build-up activities, extra care will be taken to 1) ensure the Sphere bosses are properly engaged into the Door Retainer recess following stowing and 2) make sure all Clean Room activities prevent any undesirable movement of the SPB and 3) inspect THM-SPB-MEC-208 Sphere half for scratches and change out with new if possible.
