Analyses Performed to Determine Cause

Corrective Action/ Resolution

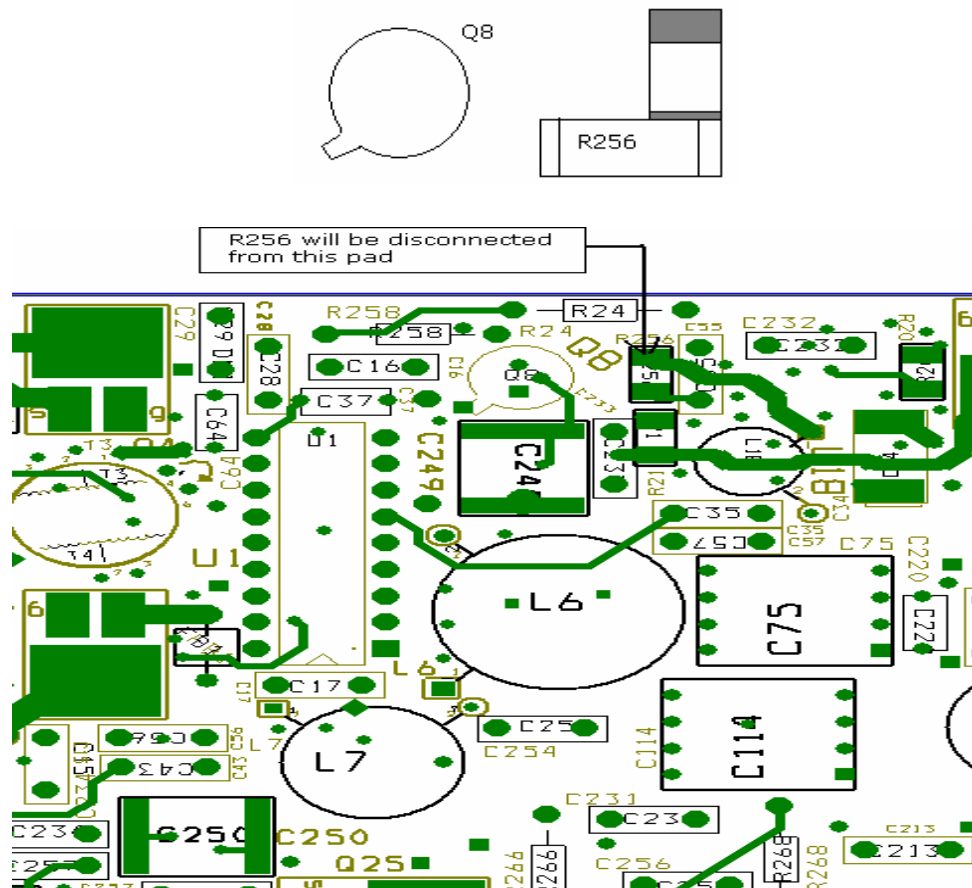
Due to a connection error on schematic R256 (2.00K) was connected to L18.
R256 (2.00K) is connected to U2 pin 3. The error on schematic connects pin 12 of U2 to Pin 3 of U2.

- 2) Install R256 2.00K D55342H07B2E00R sideways (on the top side of the board); leave the pad not connected where it connects to L18 (See figure below).
