PFR-50 Title: SPB S915 COLD TVAC DOOR RELEASE FAILIURE

Assembly : THM-SPB-MEC-001 SPB Top Level Assy	SubAssembly : THM-SPB-MEC-400 Release Panel Assy
Component : SMA Wire & Limit Switch	Units Affected: - - - x - -
Originator: Dalton/Donakowski	Units fixed: - - - x - -
Organization: SSL	Date: 9 May 05
Phone: 510.643.9240	Email : gdalton@ssl.berkeley.edu

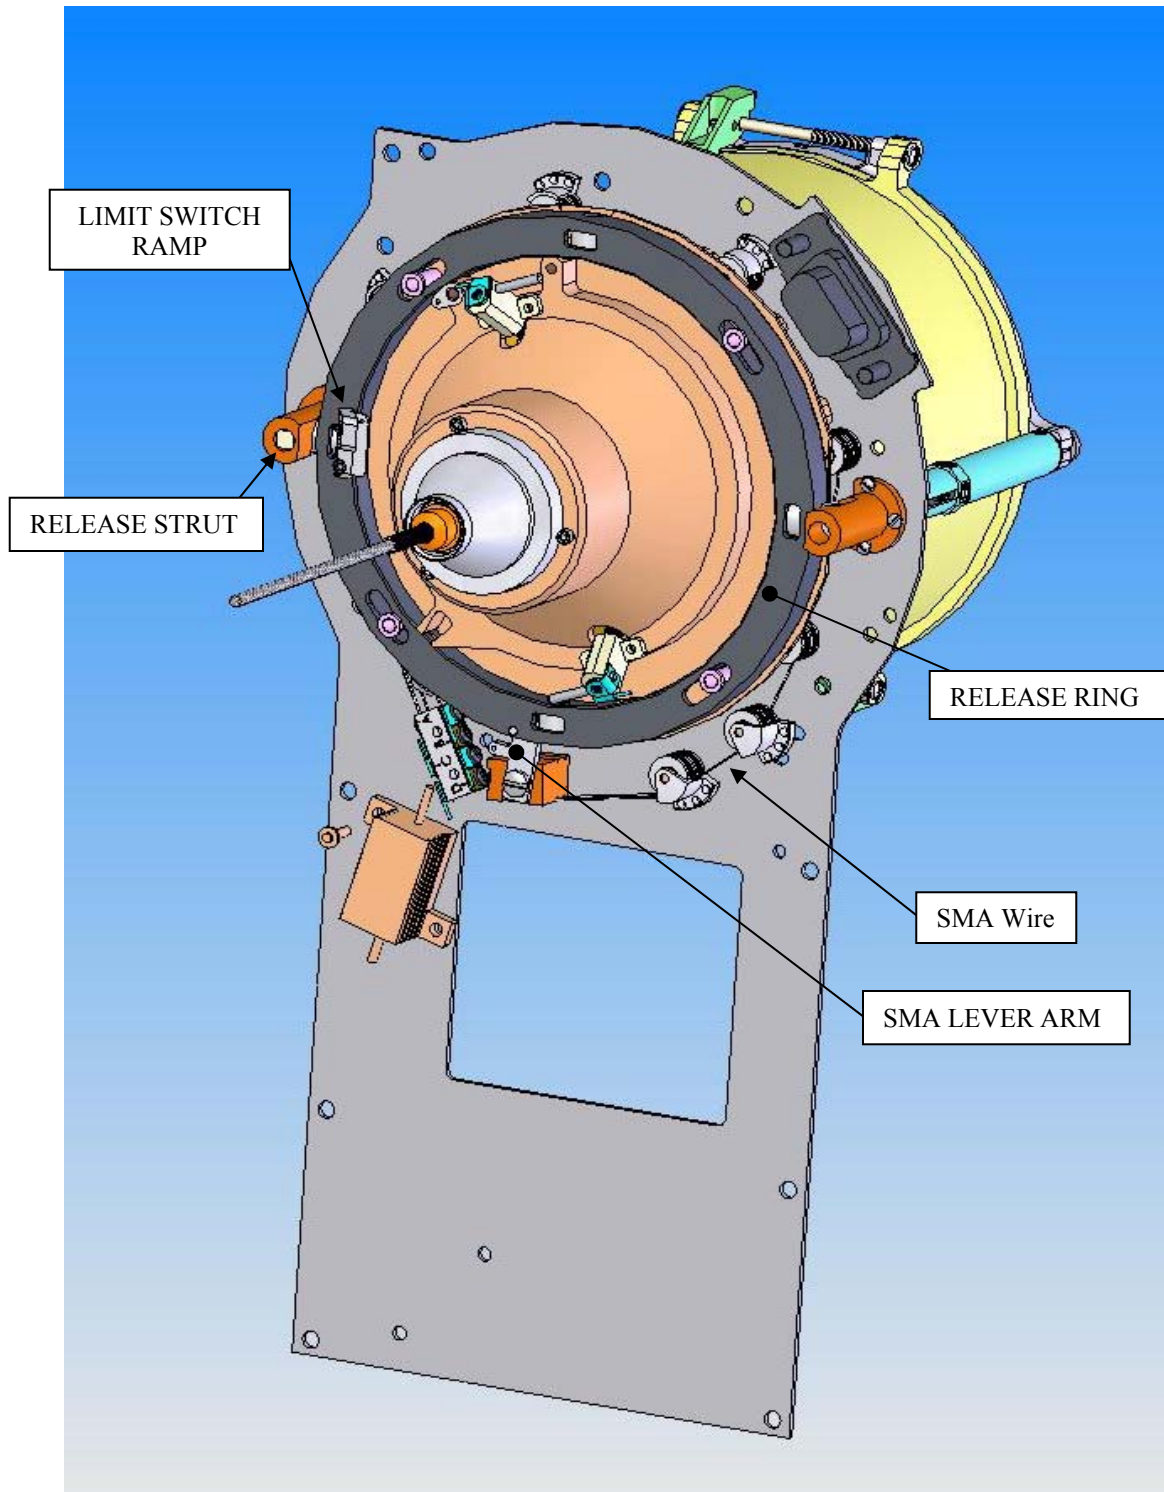
Fig. 1 THM-SPB-MEC-400 RELEASE PANEL ASSY

During cold TVAC deployment, the UUT (unit under test) did not fire the *Release Strut* (THM-SPB-MEC-631) properly, terminating the test and constituting a failure. Preliminary indications were the visual indication that the *Release Ring Assy* (THM-SPB-MEC-427) did not rotate sufficiently enough to allow the Release Struts to fire forward, which in turn normally release the *Doors* (THM-SPB-MEC-617). The SMA firing circuit drew nominal current initially, but then the circuit opened, as it should at the end of the firing, and did not reset. This indicated that the *Release Ring Assy* rotated enough to roll the circuit limit switch off the *Limit Switch Ramp* (THM-SPB-MEC-628), but not enough to fully fire the *Release Struts*. The UUT was removed from the chamber and moved to the lab bench for further investigation.

Bench tests were performed and the *Release Ring Assy* demonstrated reliability in ambient conditions. The failure in TVAC environment, in addition to worse case voltage supply levels for the test, led to believe the SMA wire was not adjusted properly and that the SMA circuit limit switch position required adjustment. Operation of the mechanism revealed that the *Limit Switch Ramp* was rolling off the limit switch and opening the SMA circuit too early. It was noted that the *Release Ring Assy* did not return to its initial position, centered on the *Release Struts*. This indicated that the SMA wire was too taught and needed to be adjusted. In addition, the *SMA Lever Arm* (THM-SPB-MEC-407) was found to be bent because of over-stress during re-stowing, exacerbated by the poor adjustment of the SMA wire.

The *SMA Lever Arm* was replaced, the SMA wire was adjusted properly, and visual checks were done on the bench to ensure the *Release Ring Assy* operated properly and returned to its initial position as required for re-stowing. Retraining of engineers and technicians was performed to avoid future failures, *Release Ring Assy Procedure* THM-SPB-MEC-440 was modified to include inspection points and operational checks. Previously built units were inspected and no anomalies were recorded. All other previously tested units performed as expected in TVAC deployments. The UUT retest in TVAC was performed satisfactorily and a workmanship re-vibrational test will be performed before Scientific Calibration to fully qualify this unit.
