PFR-054 Title: SST Sensor Damaged During Assembly Process

Assembly : THM-SST-FLT-005	SubAssembly :	
Component : Attenuator Pivot Shaft	Units Affected:	Units fixed:
Originator: R. K. Lee	<input type="checkbox"/> <input type="checkbox"/> <input type="checkbox"/> <input checked="" type="checkbox"/> <input type="checkbox"/> <input type="checkbox"/>	<input type="checkbox"/> <input type="checkbox"/> <input type="checkbox"/> <input checked="" type="checkbox"/> <input type="checkbox"/> <input type="checkbox"/>
Organization: Mechanical Engineering	Date: 05/13/2005	
Phone: (510) 643-9244	Email : rklee@ssl.berkeley.edu

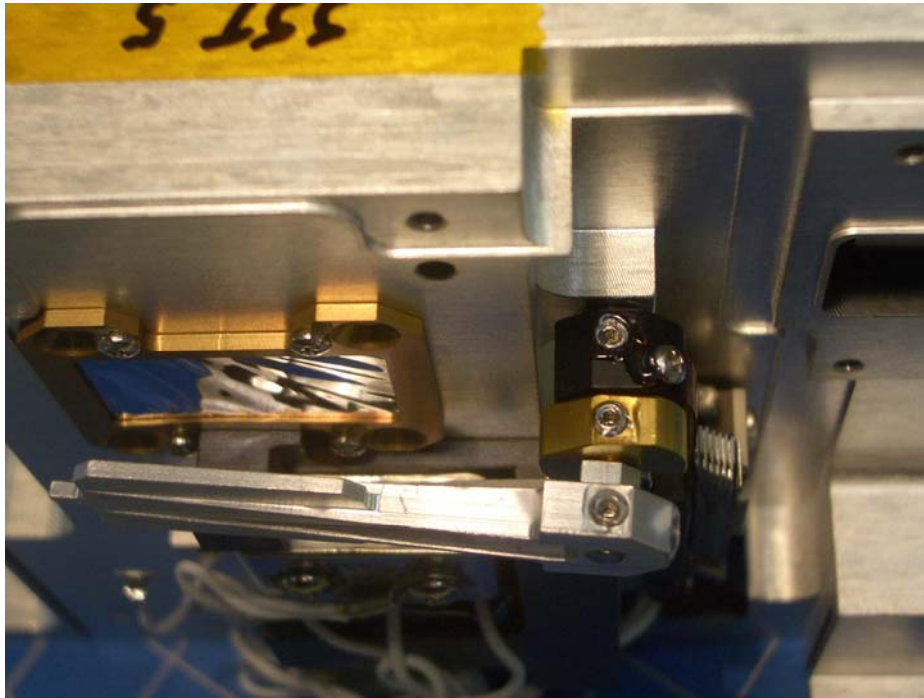
SST sensor unit (THM-SST-FLT-005) was dropped onto the floor from the B-20 calibration facility cleanroom workbench (approx. height: 30 inches) during the mechanical/electrical integration phase. Unit landed on outer attenuator which caused a large moment on pivot shaft. Figures 1 and 2 show the damaged pivot shaft and outer attenuator. Note that the sensor unit had not yet undergone any environmental tests.

1. Unit was not secured to workbench when ground strap cord became tangled with the unit.
2. Workbench clutter led to reduced work area located too close to workbench edge.

Figure 1. Deformed pivot shaft and outer attenuator (TOP VIEW)

1. Sensor units shall be secured to workbench during mechanical/electrical integration.
2. Workbench shall be cleared of unnecessary hardware and tools during mechanical/electrical integration.

Mechanical engineer recommends that the attenuator mechanism on THM-SST-FLT-005 be completely rebuilt and tested per normal flight buildup per mechanical assembly procedure THM-SST-PRC-010.

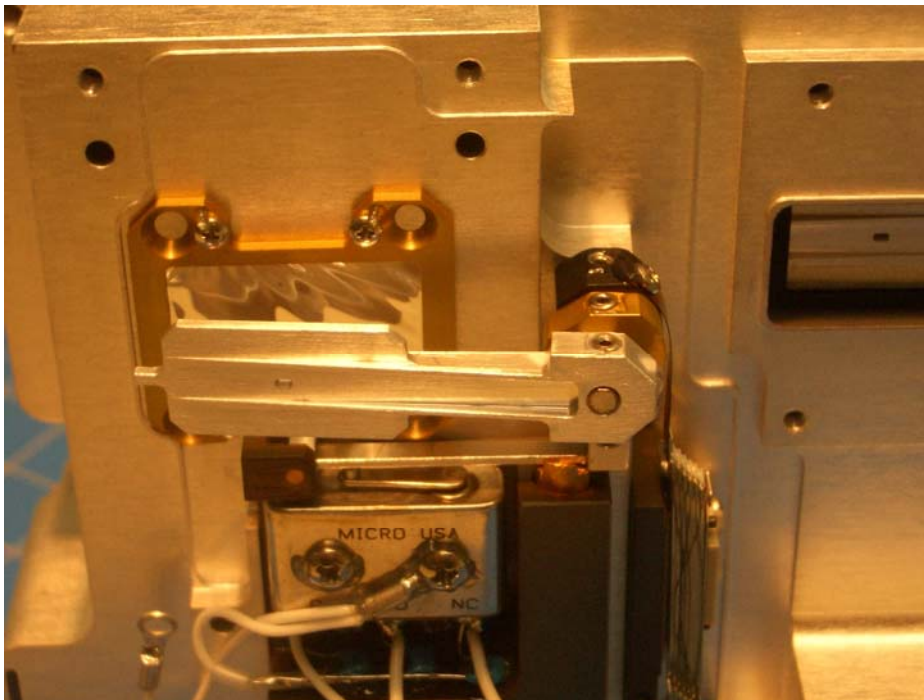
Figure 2. Deformed pivot shaft and outer attenuator (FRONT VIEW)
