PFR-057 Title: Misconnected ADC voltage reference on DFB

Assembly : IDPU	SubAssembly : DFB	
Component : ADCs (U36 and U42)	Units Affected:	Units fixed:
Originator: Chris Cully	<input checked="" type="checkbox"/> <input checked="" type="checkbox"/> <input checked="" type="checkbox"/> <input checked="" type="checkbox"/> <input checked="" type="checkbox"/> <input checked="" type="checkbox"/>	<input checked="" type="checkbox"/> <input type="checkbox"/> <input type="checkbox"/> <input type="checkbox"/> <input type="checkbox"/> <input type="checkbox"/>
Organization: LASP	Date: May 25, 2005	
Phone: 303-492-2905	Email : cully@colorado.edu

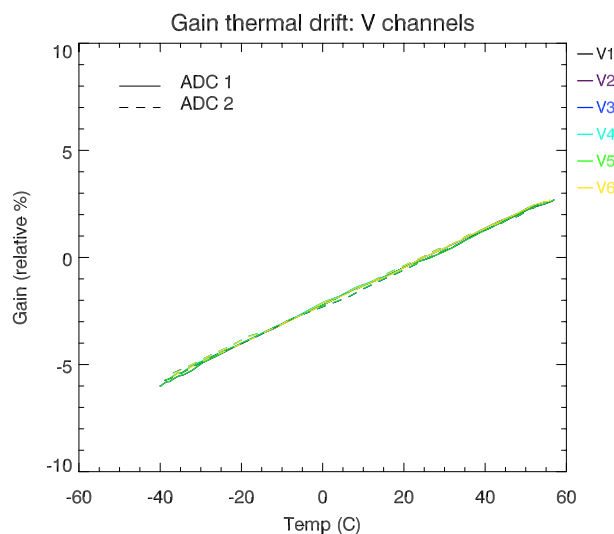
Testing of flight unit F3 (serial number 004) at LASP has revealed that the gains on all channels are strongly dependent on temperature. Results from this test for the Vx channels (i.e. +/-100V single-ended channels) are included here as figure 1.

Figure 1: Gain as a function of temperature for the Vx channels on flight unit F3 (SN004). Gain is given as relative to the gain at 25 C.

All other channels showed similar results, as did flight board F2 (SN 003). The total drift of roughly 10% over the temperature range was not expected, and is out of the acceptable range given the science requirements.

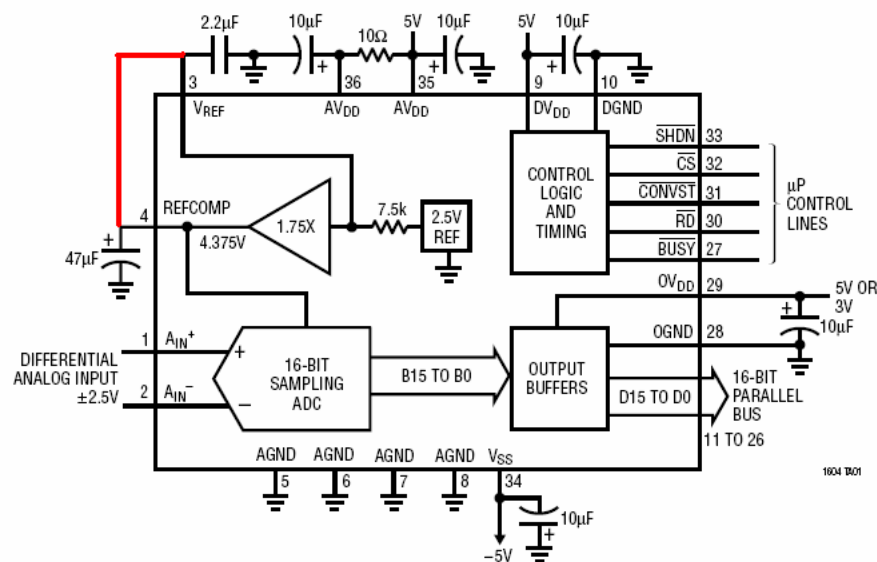
The recommended setup for using the internal 2.5V voltage reference on the LTC1604 A/D converter (from the manufacturer's data sheet) is sketched in black in figure 2. The circuit implemented on the ETU and flight boards is the same, except that it unintentionally includes the connection shown in red.

Figure 2: In black: manufacturer's recommended setup for the LTC1604, using the 2.5V internal reference. In red: extra connection on ETU and flight boards.

By connecting pins 3 and 4, the 1.75X amplifier is placed in an unstable configuration, with its output connected back to its input. The exact performance of the voltage reference circuit therefore depends on the details of the internal amplifier. Experimentally (by looking at the ETU), what happens is that pins 3 and 4 are driven to a voltage of roughly 4V, rather than the expected 4.375V. This drops the effective reference voltage from 2.5V to 2.3V, which explains the higher than expected gains. Furthermore, the effects of temperature/time/radiation on the circuit are unclear.

On the ETU, we consequently lifted pin 3 and allowed it to float. Although this isn't exactly equivalent to removing the red trace in figure 2, it did allow us to test the hypothesis that the feedback on the amplifier was causing the thermal drift problems. After lifting the pin, the voltages on pins 3 and 4 assumed the expected values of 2.5V and 4.375V, respectively. The gains for each channel also changed to what was originally expected.

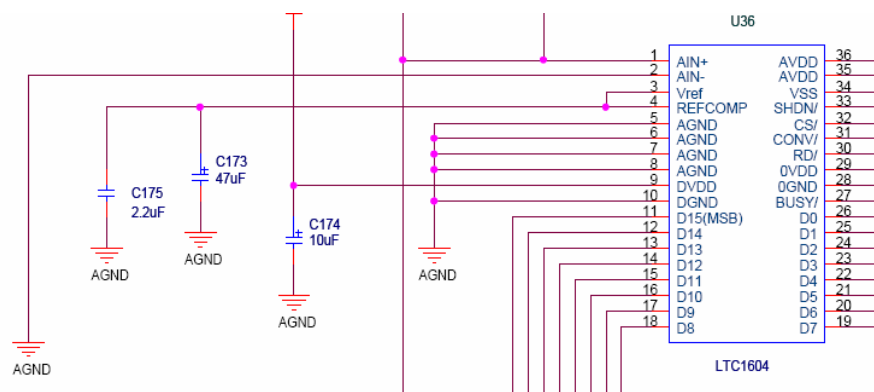
Figure 3: Fragment of the schematic for the ETU, showing A/D1. Flight board schematic is identical in this section.

It is relatively straightforward to fix this problem on the flight boards. Figure 3 is a fragment from the schematic. On the board, the traces from pins 3 and 4 connect on the top layer, before going through a via that eventually connects to C175 and C173, as shown in figure 4.

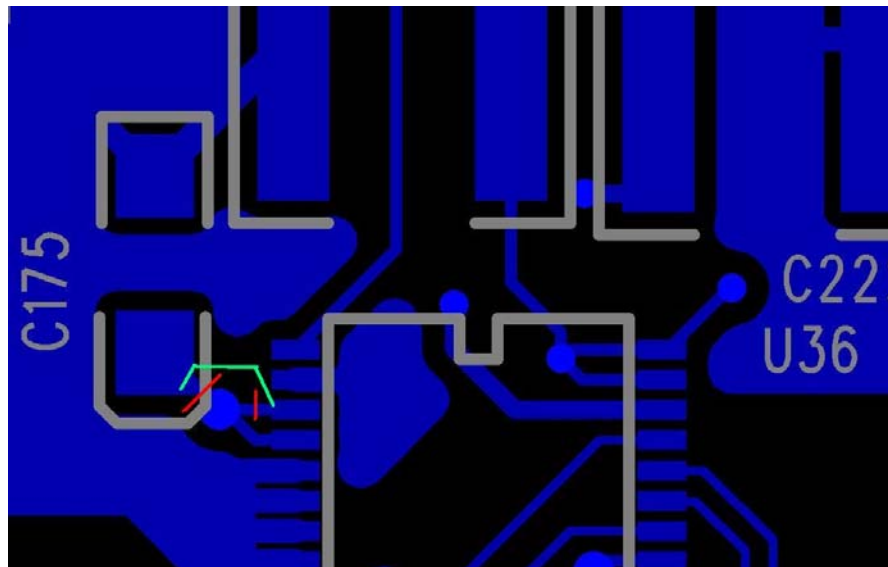
Figure 4: Layout of the top layer of the board. Green line: jumper for repair.
Red lines: cuts for repair.

1. Cut the trace between pin 3 of U36 and the via it is connected to (see red line in figure 4).
2. Cut the trace between this same via and C175 (see other red line in figure 4).
3. Solder a wire between C175 and pin 3 of U36 (see green line in figure 4).
4. Repeat above 3 steps for U42 and C179.

This repair should be done on all boards.
