PFR-075 Title: ESA HV tripping on PCB during hot TV

Assembly : FM1 IDPU	SubAssembly : PCB SN004	
Component : 28V current limiter	Units Affected:	Units fixed:
Originator: Corinna Chen	<input checked="" type="checkbox"/> <input checked="" type="checkbox"/> <input checked="" type="checkbox"/> <input checked="" type="checkbox"/> <input checked="" type="checkbox"/> <input checked="" type="checkbox"/>	<input checked="" type="checkbox"/> <input checked="" type="checkbox"/> <input checked="" type="checkbox"/> <input checked="" type="checkbox"/> <input checked="" type="checkbox"/> <input checked="" type="checkbox"/>
Organization: SSL Themis	Date: July 14, 2005	
Phone: 510 642 8030	Email : corinnac@ssl.berkeley.edu

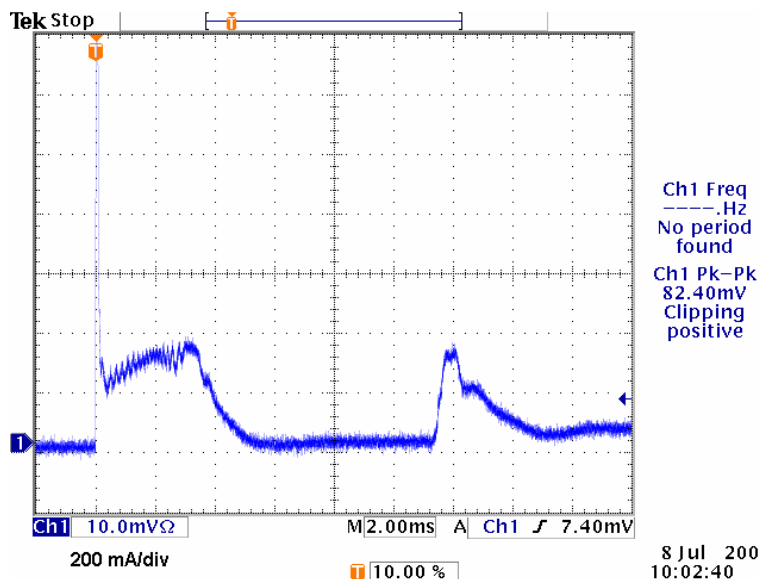
It was evident on the FM1 GSE 404 APID page that the ESA tripped off because the 28V supply monitor was off. An inrush profile was taken of the ESA Low Voltage turn on using ESA FM2. (see scope plot below)

The profile includes 2 current spikes where the second current inrush ended approximately 15ms after turn on. The PCB can only ignore transient inrush for about 9-10ms. With the inrush at around 400mA and 12ms after turn on, the PCB will certainly trip off because the current threshold is set to 250mA.

The inrush problem will require an operational fix. Now that the ESA inrush is characterized, the PCB supplies must be forced on during ESA LV and HV turn on and HV level adjustment. The force on of the current trips should be removed after for normal operations.

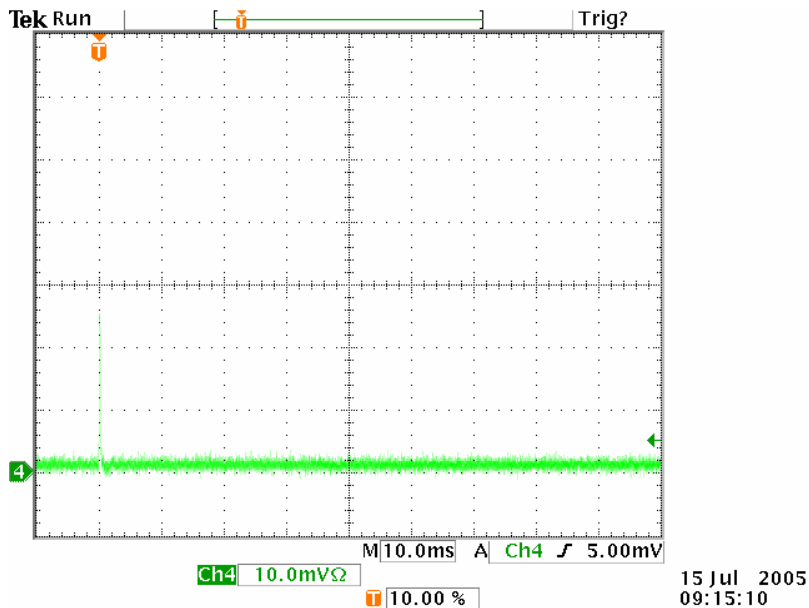
A scope plot was also taken from the ESA FM2 Calibration during the HV Turn on. This is shown below.

This plot shows a 1.3Amp inrush when turning on the HV FETs on the ESA HV Motherboard. This will also cause the PCB to trip off the ESA supplies. This was the problem that was observed in Thermal Vacuum.
