PFR-078 Title: FGM Boom Harness Discoloration

GODDARD SPACE FLIGHT CENTER
Parts Analysis Laboratory
Wire Failure Analysis

Project:	THEMIS	Part Type:	WIRE
Subsystem:	Instruments	Manufacturer:	Equator S
Requestor:	J. OSCHKE 286-3306	Part Number:	GSC-05-80499-00
Investigator:	F. Felt 286-9634	Generic Number:	28-AWG 3-TSP
Date:	29 June 2005	Date Code:	UNKWN

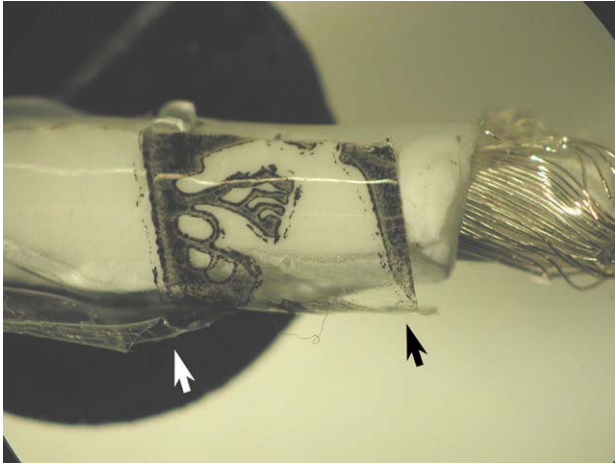
Black markings, possibly printing, were found on tape partially adhered to the stripped end of the wire. The composition of this tape was

Figure 1. Optical examination of the dark mark near the wire end revealed a transparent, tape-like material with illegible markings. The parallel sides seen at arrows suggest printing.

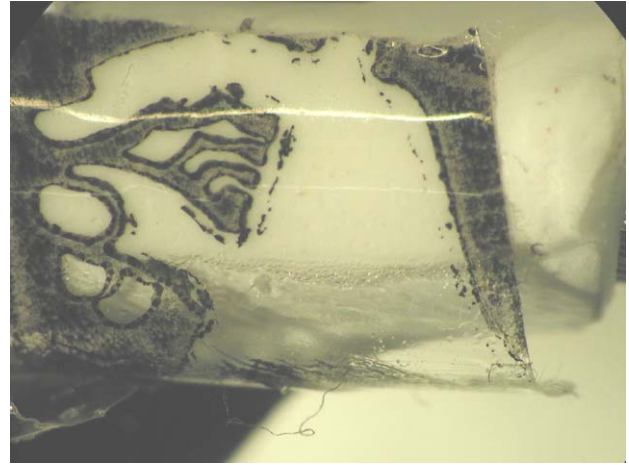
Figure 2. A close-up view of Figure 1 shows that tape and markings are detached from the wire at lower right in the image.

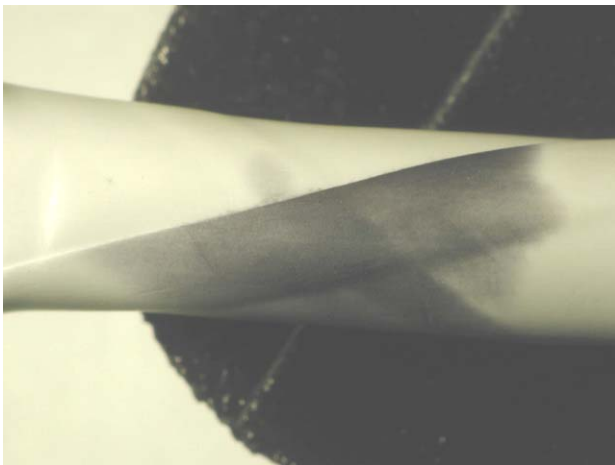
The other mark appeared to be due to scuffing of some material against the elevated wrapping of the wire insulation. Oxygen found in this location may indicate the scuff was caused by frictional between the wire and a hydrocarbon

material. However, it cannot be ruled out that the mark was carbon alone, such as a pencil marking.

Figure 3. A scuff-like mark found on the wire. The straight, diagonal edge of the mark appears to follow an elevated edge of the wrapped wire insulation.

Auger (AES) examination with depth profiling is recommended if further analysis of the scuffmark is desired.

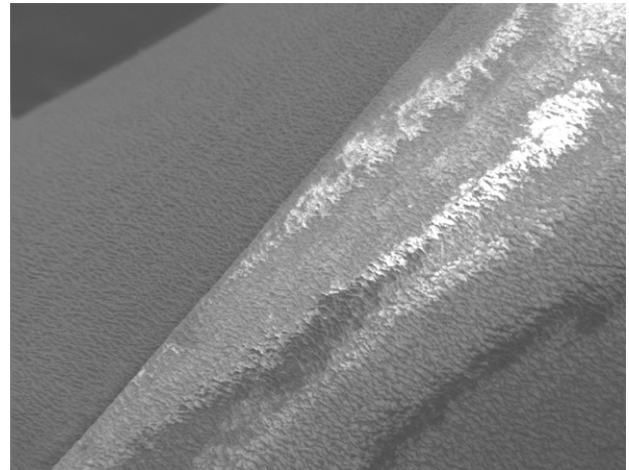
Figure 4. The straight edge of wrapped insulation is seen in this SEM photo. Material from the scuffmark was not discernible in the microscope.

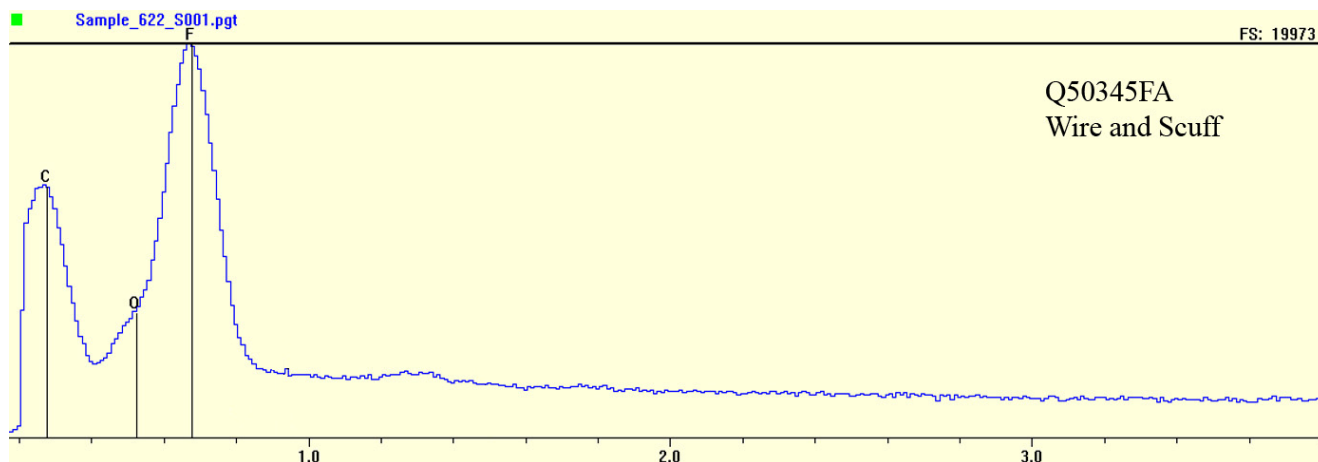
Figure 5. An EDS spectrum taken of the scuffmark exhibits mostly fluorine and carbon, likely due to the Teflon (C₂F₄) wire insulation. Note that a small amount of oxygen may also be present--a possible indication that the scuffmark is composed of some hydrocarbon material.

However, if the scuffmark were due to carbon, such as a pencil mark, penciling would be essentially invisible against the carbon-rich background of the Teflon. No metals are present. The small unmarked bump at approximately 1.35keV is a fluorine sum peak, not an additional element.

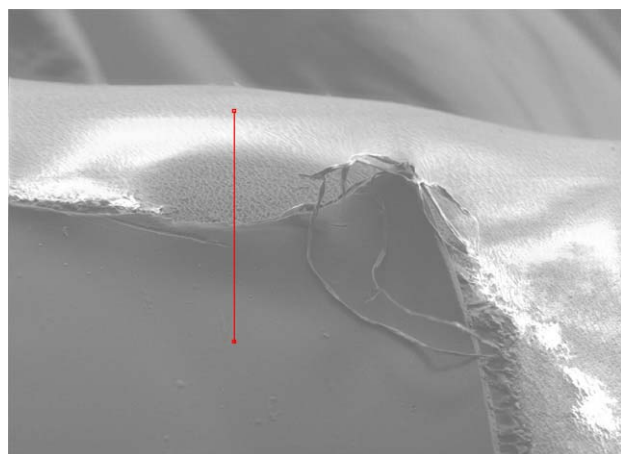
Figure 6. A SEM view of the tape (with black markings) near the stripped end of the wire. The red line marks the path of the EDS line-scan seen in Figure 7.

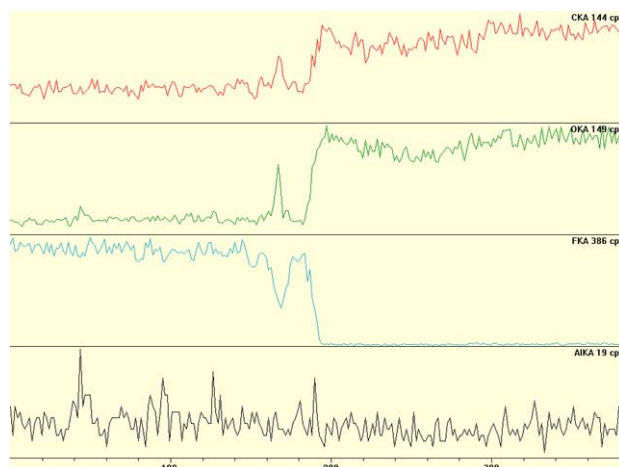
Figure 7. The left side of this line-scan matches the top of the red line in Figure 6. The blue line shows a drop in fluorine when the scan hits the tape, and an increase in carbon and oxygen, respectively red and green. The aluminum count rate at bottom is negligible and likely due to noise. The line-scan spectra are consistent with a hydrocarbon composition of the tape.
