PFR-102 Title: FGS Harness Length Too Short

Assembly : FGS magnetometer	SubAssembly : Harness	
Component : Harness	Units Affected:	Units fixed:
Originator: Paul Turin	<input checked="" type="checkbox"/> <input checked="" type="checkbox"/> <input checked="" type="checkbox"/> <input checked="" type="checkbox"/> <input checked="" type="checkbox"/> <input checked="" type="checkbox"/>	<input checked="" type="checkbox"/> <input checked="" type="checkbox"/> <input checked="" type="checkbox"/> <input checked="" type="checkbox"/> <input checked="" type="checkbox"/> <input checked="" type="checkbox"/>
Organization: UCB	Date: 09/16/05	
Phone: 510-642-5289	Email : pturin@ssl.berkeley.edu

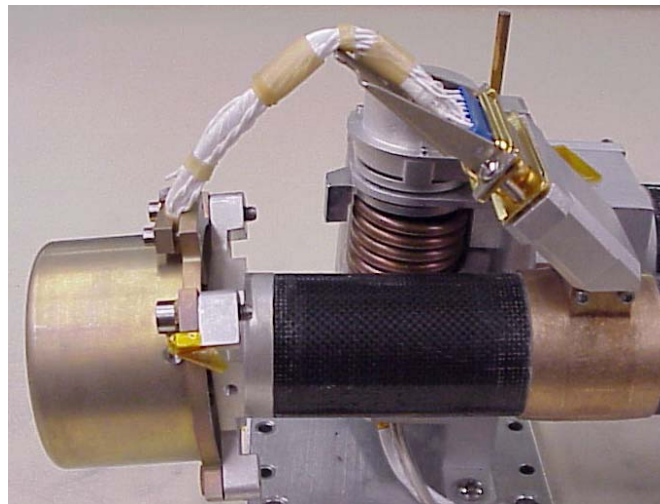
Photo 1

The FGB Boom was built to fit the FGS STM (Structural Test model) supplied by the FGM team. When the flight FGS units were installed on the FM2&3 FGBs, it was discovered that the flight harnesses were 1-3/4" shorter than the STM harness. The harnesses were installed despite not fitting correctly, possibly damaging conductors. This resulted in the harnesses being pulled sharply over the connector backshell edge and where the harness exits the magnetometer (see photo 1). This is an unacceptable condition for flight as it is likely to cause harness damage.

This problem was caused by the flight harnesses being fabricated at a different length than the STM harness length.

Rather than sending the sensors back to Germany for longer harnesses, which would entail significant rework and retesting, it was decided to modify the harness connector backshell to provide a shorter path and appropriate curvature for the harness. The backshell sides were cut, the tray was bent to a 30 degree angle, and reinforcing clips were bonded over the cuts to strengthen the backshell (see photo 2). This reshaped the harness into an acceptable path (see photo 3). The FM2&3 harnesses have been inspected at the completion of the FM2&3 suite thermal vac test for any damage caused by the excessively sharp bends and none was found. All of the flight harnesses have had modified backshells installed, and have been overwrapped with Teflon tape for protection.
