PFR-105 Title: SPB Turns Counter Faliure

Assembly : THM-SPB-MEC-001	SubAssembly : THM-SPB-MEC-500	
Component : THM-SPB-MEC-500	Units Affected:	Units fixed:
Originator: Dalton	<input checked="" type="checkbox"/> <input checked="" type="checkbox"/> <input checked="" type="checkbox"/> <input checked="" type="checkbox"/> <input checked="" type="checkbox"/> <input checked="" type="checkbox"/>	<input type="checkbox"/> <input type="checkbox"/> <input type="checkbox"/> <input type="checkbox"/> <input type="checkbox"/> <input type="checkbox"/>
Organization: SSL - UCB	Date: 10/10/05	
Phone: 510.643.9240	Email : gdalton@ssl.berkeley.edu

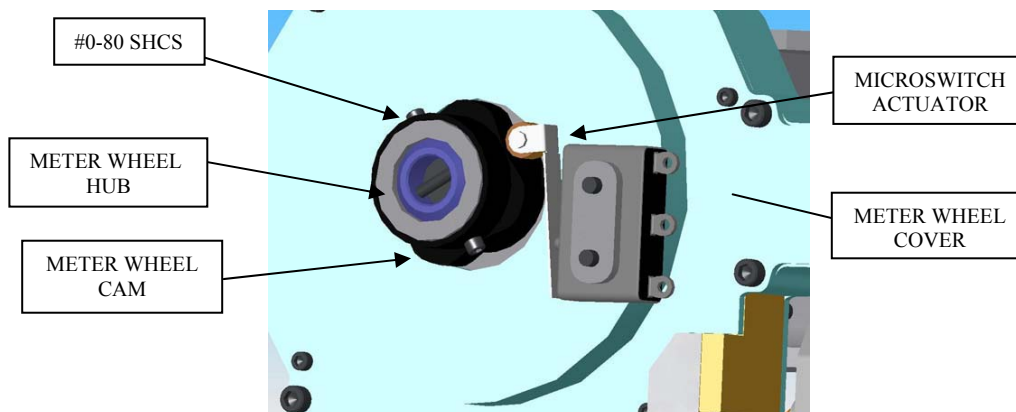
Fig1. Meter Wheel Assembly

During EFI suite level integration on F4, the turns counter was indicating only half the number of turns on two of the SPB's.

This problem was verified by visually counting the turns and also by measuring the length of cable off the spool. All indications were consistent with the hypothesis that the turns counter was clicking on only half the lobes of the *Meter Wheel Cam* (see fig. 1). While observing the cam, the SPBs were run and it was noted that the roller actuator on the microswitch was riding on top of the 2X #0-80 SHCS that hold the *Meter Wheel Cam* on the *Meter Wheel*. This would cause the Turns Counter to report only half the number clicks. It was also determined that the microswitch actuator could have been bent during a re-stow evolution, causing the actuator to fall off the cam path and onto the SHCS.

The #0-80 SHCS will be replaced with PHS, which are only half the height and will clear under the *Microswitch Actuator* roller as the cam rotates.
