PFR-128 Title: Antenna Coax Interferes with FGB

Assembly : Probe Harness	SubAssembly : Antenna Coax	
Component :	Units Affected:	Units fixed:
Originator: Paul Turin	<input type="checkbox"/> <input type="checkbox"/> <input type="checkbox"/> <input type="checkbox"/> <input type="checkbox"/> <input type="checkbox"/> <input type="checkbox"/>	<input type="checkbox"/> <input type="checkbox"/> <input type="checkbox"/> <input type="checkbox"/> <input type="checkbox"/> <input type="checkbox"/> <input type="checkbox"/>
Organization: SSL	Date: 12/20/05	
Phone: 510-845-2418	Email : pturin@ssl.berkeley.edu

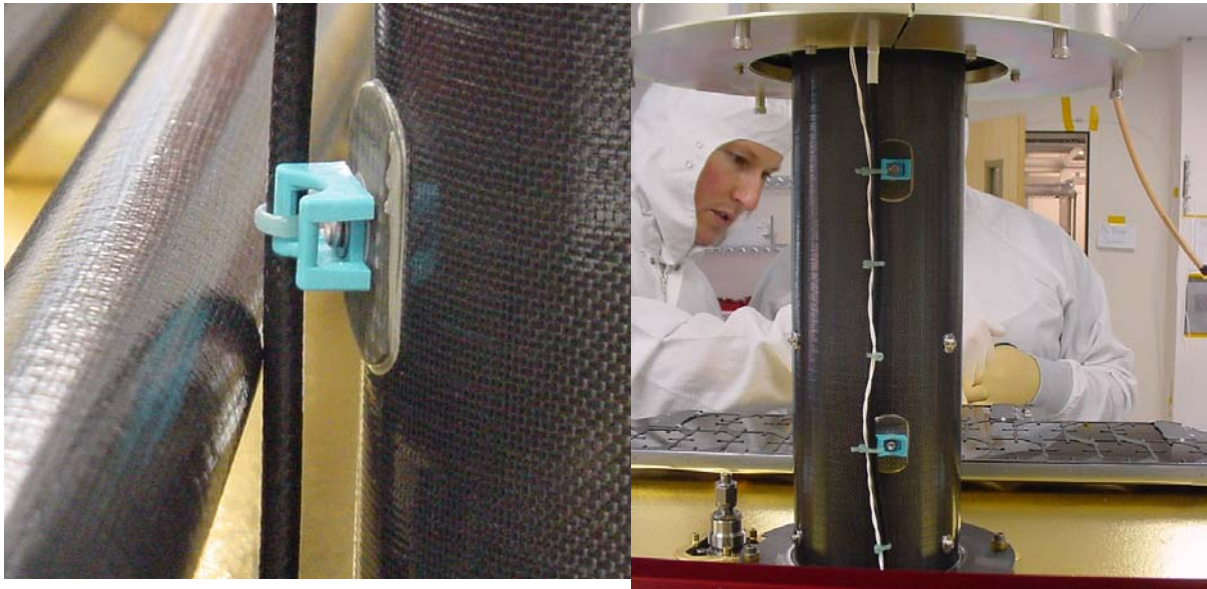
During integration of the FGM Boom onto Probe 2 it was discovered that the antenna coax interferes with one of the FGM boom tubes. The coax was laced to the end of one ear of the bonded clip, pushing the coax fairly far from the AXB tube. We rotated the coax and tie-wrap around the clip to move it inward, but this still did not provide enough clearance:

Both the FGM tube and the AXB tube (over the coax) will be blanketed, worsening the interference.
