PFR-233 Title: IDPU Sep Loop Wiring Exhibits Open Circuit

Assembly : Probe F1	SubAssembly : Umbilical Harness	
Component : Probe Extension Cable	Units Affected:	Units fixed:
Originator: S. Harris	<input checked="" type="checkbox"/> <input type="checkbox"/> <input type="checkbox"/> <input type="checkbox"/> <input type="checkbox"/> <input type="checkbox"/>	<input checked="" type="checkbox"/> <input type="checkbox"/> <input type="checkbox"/> <input type="checkbox"/> <input type="checkbox"/> <input type="checkbox"/>
Organization: UCB	Date: 12/15/2006	
Phone: 510-643-3395	Email : sharris@ssl.berkeley.edu

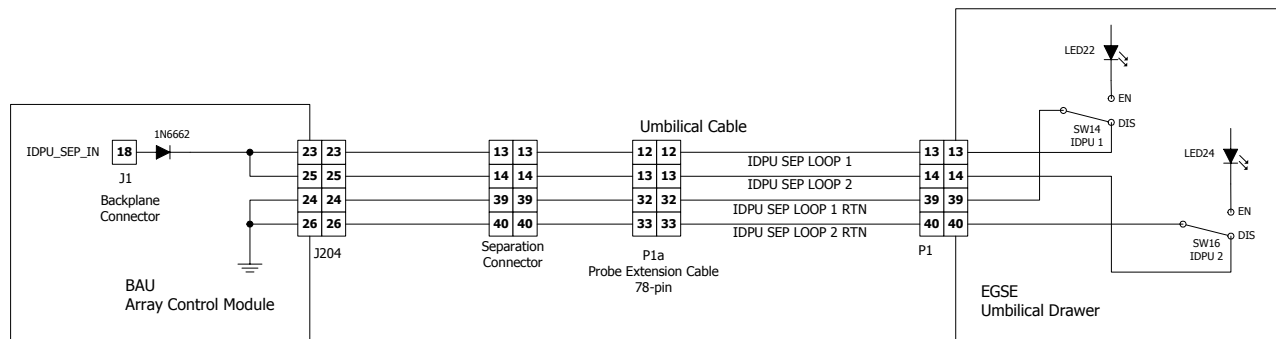
Figure 1: Partial schematic of IDPU Sep Loop circuit

An examination of wiring diagrams and schematics determined that this indication could mean a variety of things, but that in any case it was safe to try to turn on the IDPU Actuator power, and see if it was actually disabled. This was done, and the IDPU Actuator power turned on normally. Standard IDPU actuator tests, as called out in the LPT, were performed normally, with this LED in the OFF state. A partial schematic of the IDPU Sep Loop circuit is shown in Figure 1 for reference.

We then disconnected the Umbilical at the Probe Extension Cable Connector, P1a, and measured the resistance between pins 32 and 33, looking into the Probe. This resistance measured OPEN. As a check we measured both pins 32 and 33, with respect to pin 34 which is a power ground (DPC Power Rtn). The resistance between 32 to 34 measured 0.4Ω, while the resistance between 33 to 34 measured OPEN. This indicated that pin 33, "IDPU Inhibit Sep Loop2 RTN", is OPEN. The LED did not light because the ground path for the LED current is disconnected.

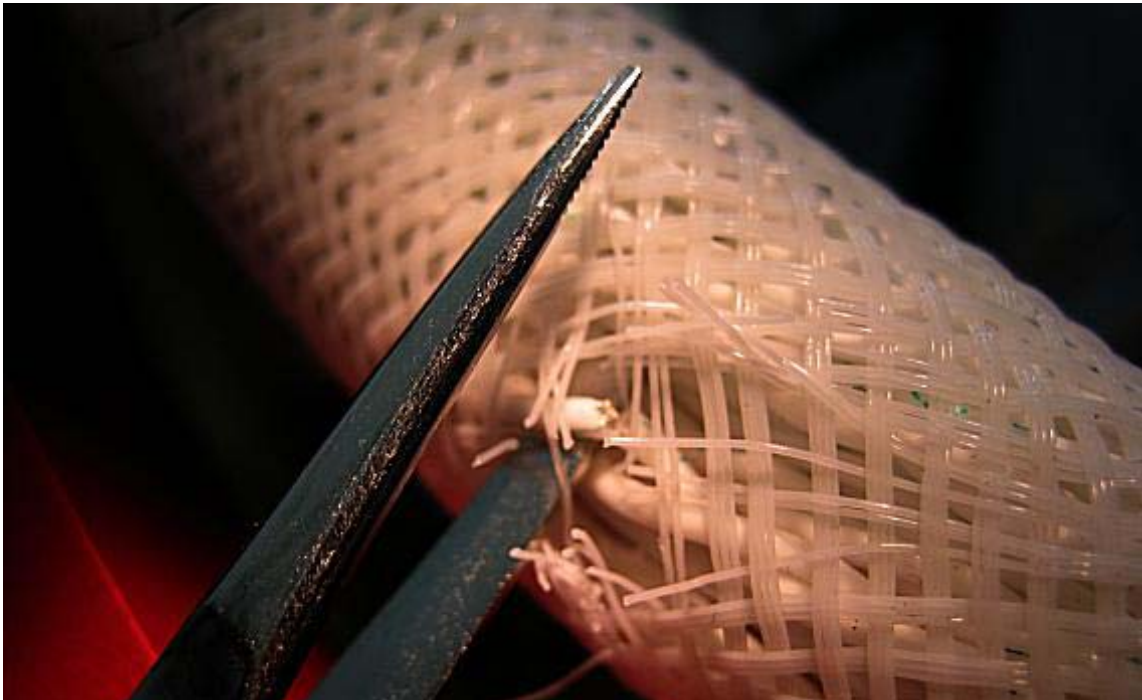
To further troubleshoot this issue, the Probe was mounted on the Roll-Over Fixture, to make the Probe Extension Cable and Separation Connector accessible. As a first step, the ty wrap that had been removed for the Bolt Cutter installation, a recently performed procedure, was removed again, and the underlying cable bundle was examined for any damage. This inspection yielded immediate results. Please refer to Figure 2. The outer, braided cable jacket had obviously been cut. Further inspection of the wires in the exposed bundle showed that at least one wire had been nicked, with wire strands visible. A quick ohmmeter check verified that this wire was indeed the cause of the OPEN circuit for the signal "IDPU Sep Loop 2 Rtn".

Figure 2: Snapshot of Probe Extension Cable where jacketing was cut, and wire was cut.

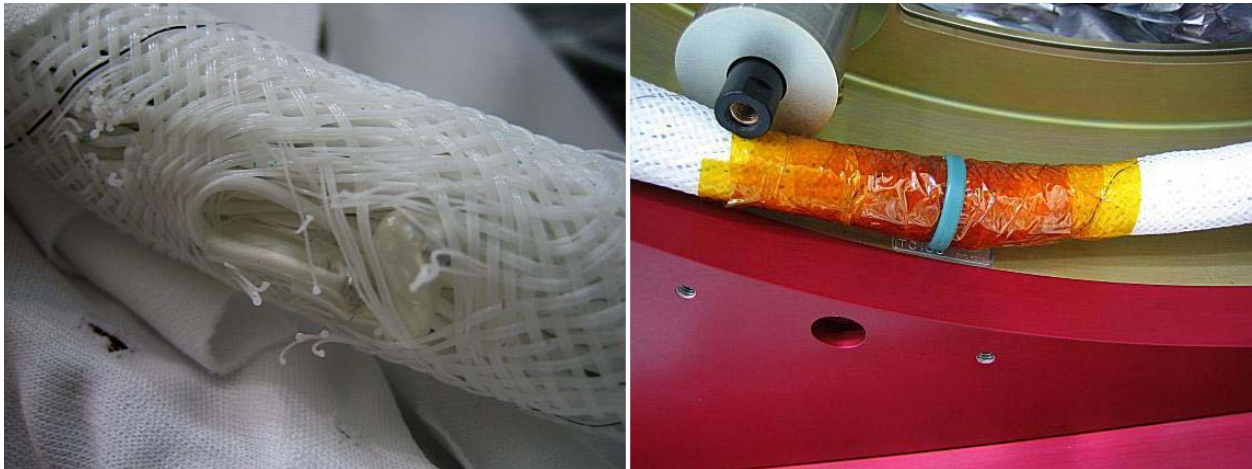
Figure 3: Details of completed repair

With the wire bundle exposed and accessible, it was determined that a repair was feasible and desirable. Since the cable bundle doesn't provide enough slack for the wire, to perform a solder splice, a short length of wire was used to make the connection between the two ends of the cut wire, and soldered in accordance with NASA practice. Some detail of the repair is visible in Figure 3.

Prior to making the splice, a thorough visible inspection, of the area was done, using magnification, to verify that no other wires had been damaged. No evidence of other cut wires or nicked wires was found. As further evidence of this fact, it's notable that the cut wire is one wire in a twisted pair. The other wire in the pair was examined thoroughly, and no evidence of damage to this neighboring wire was visible.

After the repair was completed, the braided jacket over the cable bundle was taped closed, and the bundle was secured with a ty wrap. Electrical checks were performed to verify that the repair was intact, and other Umbilical functions were unaffected. These electrical checks are specified in Table 1, using a 78-pin break-out-box on the Probe Extension Cable Connector, P1a. A post repair Bus Functional Test should be completed also, to verify all Umbilical Functions.
