PFR-012 Title: EFI Ferrule Spring contact problem

Assembly : EFI Cable/Preamp Assy		SubAssemb	SubAssembly : Preamp PWB #50		
THM-SPB-MEC-840-009 in SPB unit					
S908					
Component :	Ferrule spring				
Originator: Arthur Hull		Organizatio	Organization: UCB/SSL THEMIS EFI		
Phone : (510)-643-0502		Email : ahu	ıll@ssl.berkeley.edu		
Failure Occurred During (Check one $$					
Functional test \Box Qualification test \Box S/C Integration \Box Launch operations \Box Other (Flight Assy)					
Environment when failure occurred:					
Ambient	\Box Vibration	□ Shock

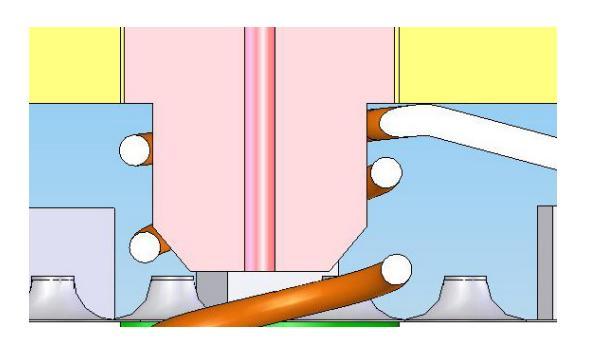
The electrical contact between ferrule spring and ferrule in the EFI SPB cable/preamp assembly was found to be problematic. The problem revealed itself during a LPT performed on the SPB mechanical assembly S908 prior to environmental testing. The resistance between the bias pin at the breakout box to the sphere input of the spin plane boom (SPB) unit was expected to be 75 MOhm. However a continuity check of the SPB mechanical unit revealed that the electrical path was open. Additional checks from the bias pin and the positive and negative supply line revealed that the open was not in the path from the breakout bias pin to the preamp and must be in the path from the preamp input to the sphere. The preamp was partially deployed to expose the sphere, fine wire and preamp. Subsequent measurements indicated that there was continuity between the fine wire and the sphere, however, the continuity between the fine wire was pulled away from the preamp and 75 MOhm resistance value was measured when the tension was removed. This revealed a problem with electrical contact between the ferrule spring and the ferrule. All four of the F1 units and the three remaining F2 units were subsequently tested, and only one additional F2 unit was found to have an open electrical contact.

We unpacked the preamp assembly for further evaluation. We measured the length of the ferrule spring, its excursion from the sphere mount, the ferrule counterbore depth, and the dimensions of the usher top and found these measurements to be consistent with design. The uncompressed height of the spring on the PWB was measured and compared to springs worst case compressed height expected from design tolerance in the packaged configuration. We found that the uncompressed height was sufficient to provide electrical contact (e.g., 125 mil uncompressed versus 109 mil worst case expected height in packaged configuration). Using the ferrule spring soldering jig and viewing the engagement under a microscope, we discovered that the spring, which was found to fit loosely over the ferrule, was contacting the PEEK sphere mount. This prevented the spring from seating properly and making electrical contact on the designed ledge of the ferrule (see Figure 1). This seating problem exists in all of the SPB preamp units. However, an open circuit was probably not manifested in six of the eight SPB mechanical units tested because the springs in the other units probably fit sufficiently snug onto the ferrule to make contact laterally on the ferrule. A lateral contact point between the ferrule and the spring was not part of the original design and does not provide a consistent and reliable contact, owing to the differences in the spring diameters and differences in interference via the PEEK from unit to unit.

Figure1 Illustration of spring contact problem

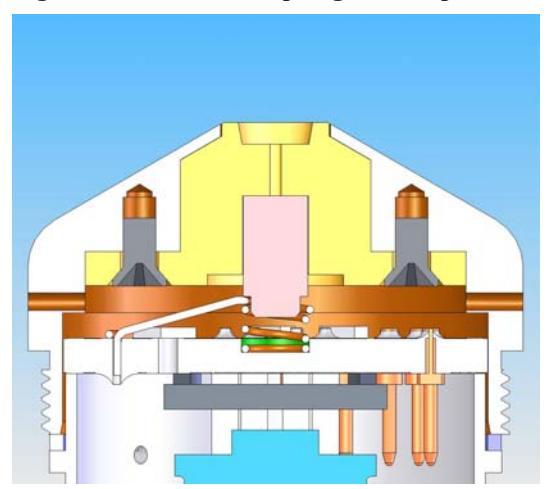
Figure 2 New Design to Fix problem

- Sphere mount: Add a counterbore 20 mil deep in the sphere mount so that the spring is clear of the sphere mount (see Figure 2).
- Ferrule: 1) Change material to beryllium copper or copper, 2) increase the ferrule shaft length by 20 mil to clear spring from sphere mount and to increase the contact force at the ledge, 3) reduce the tip diameter of the ferrule by 5 mil to allow spring to engage ferrule at the ferrule ledge, as opposed to the sides of the ferrule, and 4) shorten the ferrule tip by 10 mil to guarantee enough clearance between the ferrule and the PWB.
