## PFR-028 Title: DFB resistor misplacement on FM-2

Assembly :		SubAssembly : DFB SN003	
<b>Component :</b>			
Originator: Ken Stevens		Organization: LASP	
Phone: (303)449-3887		Email : <u>ken.stevens@lasp.colorado.edu</u>	
<b>Failure Occurred D</b> × Functional test	<b>uring (Check one</b> $$ ) Qualification test	□ S/C Integration	□ Launch operations
Environment when failure occurred:   × Ambient □ Vibration □ Shock □ Acoustic			
Thermal		□ Thermal-Vacuum	□ EMI/EMC

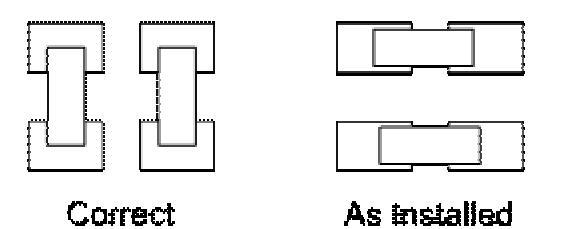
During initial visual inspection at LASP, it was noted that two pairs of resistors were incorrectly installed.

Resistor pairs R220-R222 and R228-R229 were installed incorrectly. Since this issue had previously been observed (on DFB SN002), the anomaly was detected using visual inspection. The picture below shows the problem.

RAM chip U55 is 25mA and the 50 mA that would have flowed through the 100 ohm resistor given +5V on one pin and 0V on the other would have exceeded this limit. The RAM chip (U55) could have been stressed in this situation and I recommend replacing it. These resistors should be checked before powering up future boards since the situation was repeated on FM-2 after occurring on FM-1.

The resistors were removed and then soldered in the proper orientation and the board has functioned properly since. Although this problem was detected and corrected prior to powering up the board at LASP, if digital power was applied during analog testing at Berkeley then the integrity of the parts could be in question. If digital power was applied during previous testing, then the following comments are relevant... Aref Nammari confirmed that the result of the incorrect installation is that the FPGA pins would be connected together through a 100 ohm resistor and also that the SRAM pins would be connected together through a 100 ohm resistor. The FPGA should be fine since the current drive capability exceeds 50mA. However, R228 and R229 are connected to data bits on the SRAM and these could have driven into each other during a read operation. The absolute maximum rated value for the average output current on the
