PFR-059 Title: Cable Pull Test Failure

Assembly : EFI Cable Assy THM-SPB-	SubAssembly :
MEC-820-024	
Component : Cable	
Originator: Daniel Schickele	Organization: UCB/SSL THEMIS EFI
Phone : (510)-643-9247	Email : dschickele@ssl.berkeley.edu
Failure Occurred During (Check one $$

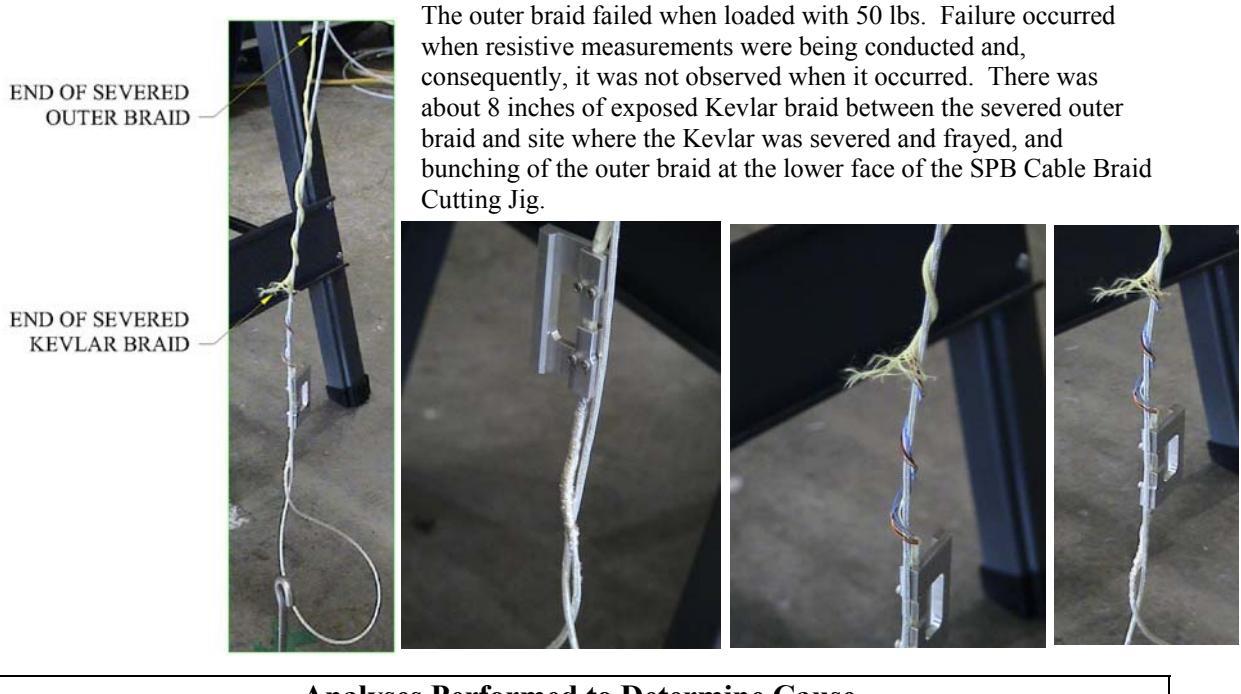
(How do we know how the failure happened? Was it a bad part, bad handling, what?) It appears that the outer braid slipped so that it was taking the load rather than the inner Kevlar braid. This loading caused the outer braid to fail which then continued to slide until enough of the outer braid accumulated at the lower portion of the jig to prevent further slippage. The jig then stopped suddenly, and the resulting shock broke the Kevlar braid. The most probable cause for the slippage was either insufficient clamping force due to either improper tightening of the clamp screws or warpage of a clamp jaw.

(How do we fix the unit? And how do we make sure it doesn't happen again?) This cable is one of four FM6 spare cables of which all the others passed the Pull Test. Consequently, the decision was made that it was not necessary to replace this cable and there is no corrective action required.
