PFR-096 Title: EFI Y Current Monitor Unstable				
Assembly : EFI		SubAssembly : Y	SubAssembly : Y-Axis	
Component :	Unknown	Units Affected:	Units fixed:	
Originator: John Bonnell		x o o o o o	x o o o o o	
Organization: UCBSSL		Date: 16 Sep 2005	Date: 16 Sep 2005	
Phone:510-642-0852		Email :jbonnell@	Email :jbonnell@ssl.berkeley.edu	
Failure Occuri	red During (Check on	ie √)		
X Functional test \Box Qualification test \Box S/C Integration \Box Launch operations \Box Other (Flight Assy)			ns 🗆 Other (Flight Assy)	
Environment v	vhen failure occurred	:		
XAmbient	Vibration	□ Shock	Acoustic	
□ Thermal	Vacuum	Thermal-Vacuum	□ EMI/EMC	
Problem Description

Problem/Failure Report THM_PFR_096

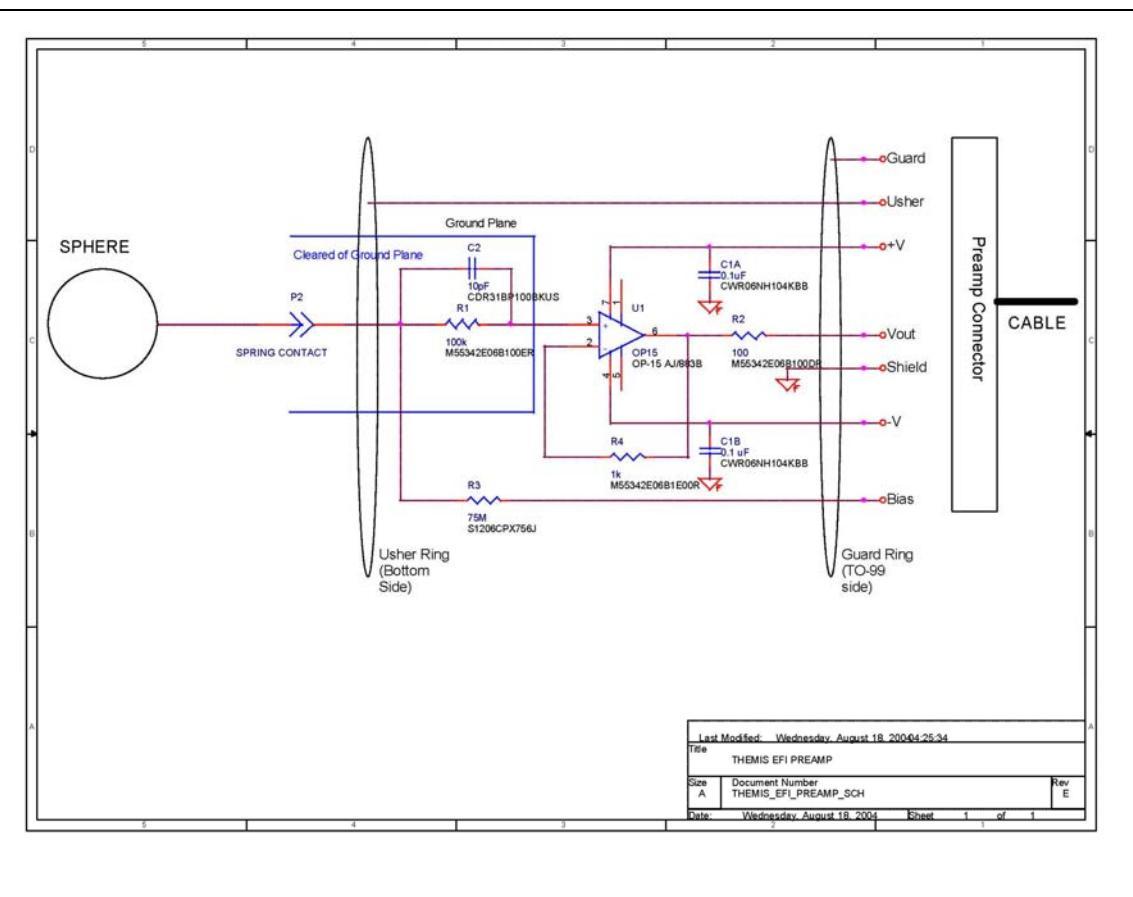
Figure 1: Schematic of THEMIS EFI Flight preamp.

The EFI preamp circuit is essentially a high-input-impedance, unit-gain amplifier circuit used to buffer between the high-source-impedance voltage fluctuations picked up by the EFI antenna element (marked SPHERE in the schematic) and the significant, primarily capacitive load (30-ohm series resistance, approx. 1700-pF capacitance to analog ground) of the coaxial antenna cable. Power (+/- 10-volt analog, with floating ground) is supplied to the unit via the +V, –V, and SHIELD connections. C1A and C1B are 0.1-uf, polarized tantalum capacitors included as power supply noise bypass capacitors.

The preamp uses the Analog Devices OP-15 operational amplifier, with ESD input protection and bypassing provided by R1 and C2, and output stabilization under the significant capacitive load is provided by R2. R3 is part of a current-biasing circuit for the input electrode, and R4 is a modest (1-kohm) resistor provided to stabilize the feedback path.

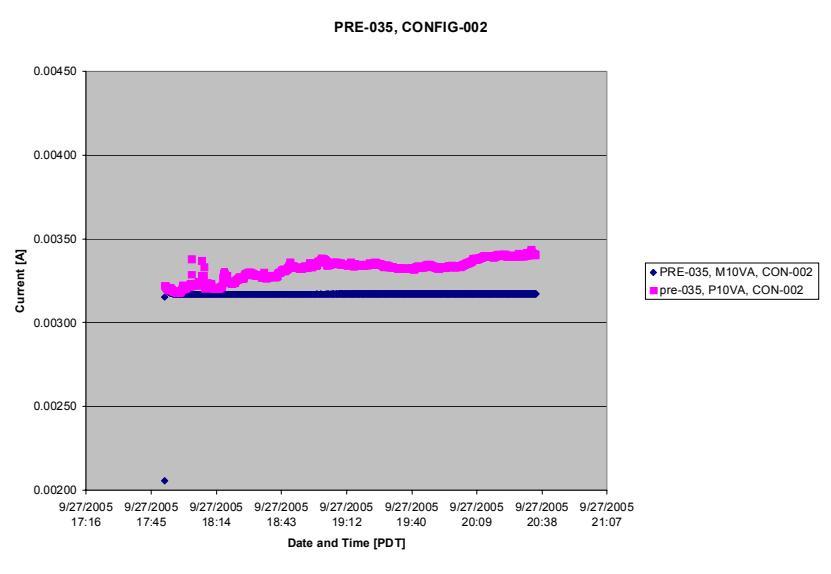
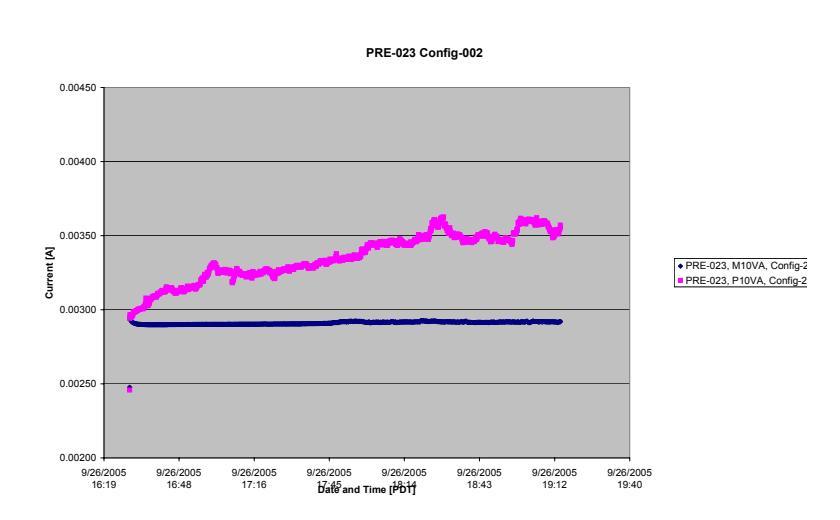
- 2. PRE-023 misbehaved most; its P10VF current consumption increased by 0.6 mA over the 3-hour test (from 2.9 mA up to 3.5 mA, or about 20%), and stabilized at around 3.75 mA 7 hours into the 15-hour test. Spikes of a few tenths of a mA lasting for several minutes were also present in the P10VF record.

- 3. PRE-035 showed similar, but more modest current consumption increases. Over the 3-hour test, its M10VF consumption was stable, and its P10VF consumption increased by 0.2 mA, from 3.2 to 3.4 mA. Its behavior was similar during the 15-hour test, ramping up from 3.2 to 3.4 mA on the P10VF, while the M10vF consumption remained stable. PRE-035 also showed episodes of increased current consumption, with spikes up to 3.5 mA that lasted for several minutes at a time.

"PRE-023, CONFIG-002" and "PRE-035, CONFIG-002" are 3-hour current consumption tests, with the preamp output (VOUT) terminated to AGND via a 100-kohm resistor, and preamp input directly terminated to AGND.

"PRE-035, CONFIG-003" and PRE-035, CONFIG-003" are 15-hour current consumption tests, with the preamp output (VOUT) terminated to AGND via a 100-kohm resistor, and preamp input terminated to AGND via the on-board 75-Mohm bias resistor (R4).

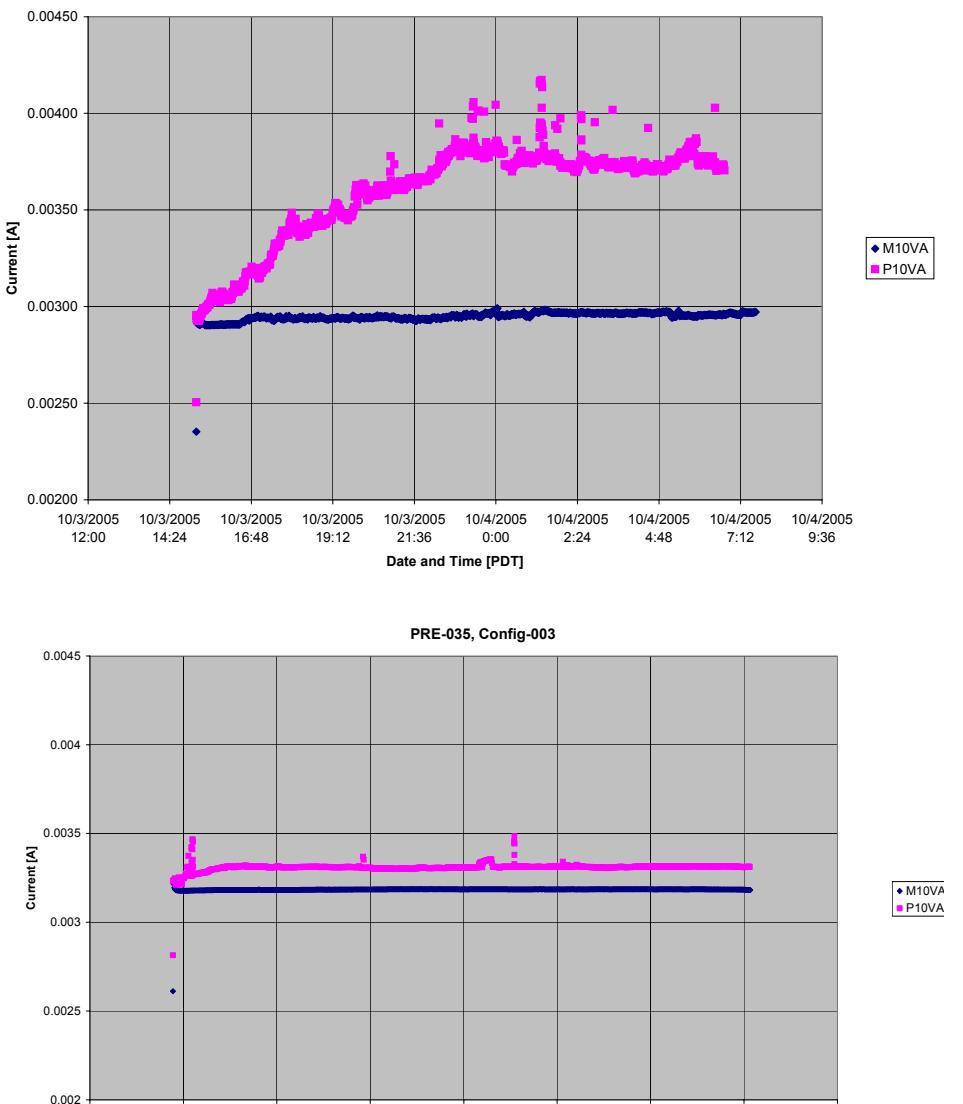
PRE-023, Config-003

C1A and C1B were replaced on PRE-023, and packaged for possible DPA (see *Assembly_Repair-Rework_THM_rev4-thm-efi-pre-023-revA.doc* for details of the rework procedure); the 15-hour current consumption test was run, and it was found that current consumption was nominal and very stable, with less than a 0.01-mA (10-uA) change in current consumption over the test, and no evidence of the sporadic increases in current consumption observed with the original pair of tantalum bypass capacitors in the circuit. Charts showing the current consumption test results are included in Appendix A below.

"PRE-023, RW1, CONFIG-003" is a 15-hour current consumption test using the PRE-023 unit with replacement tantalum bypass capacitors. Input and output termination is as in the preceeding CONFIG-003 tests.
