PFR-181 Title: F3 EFI SPB IMONs Unstable

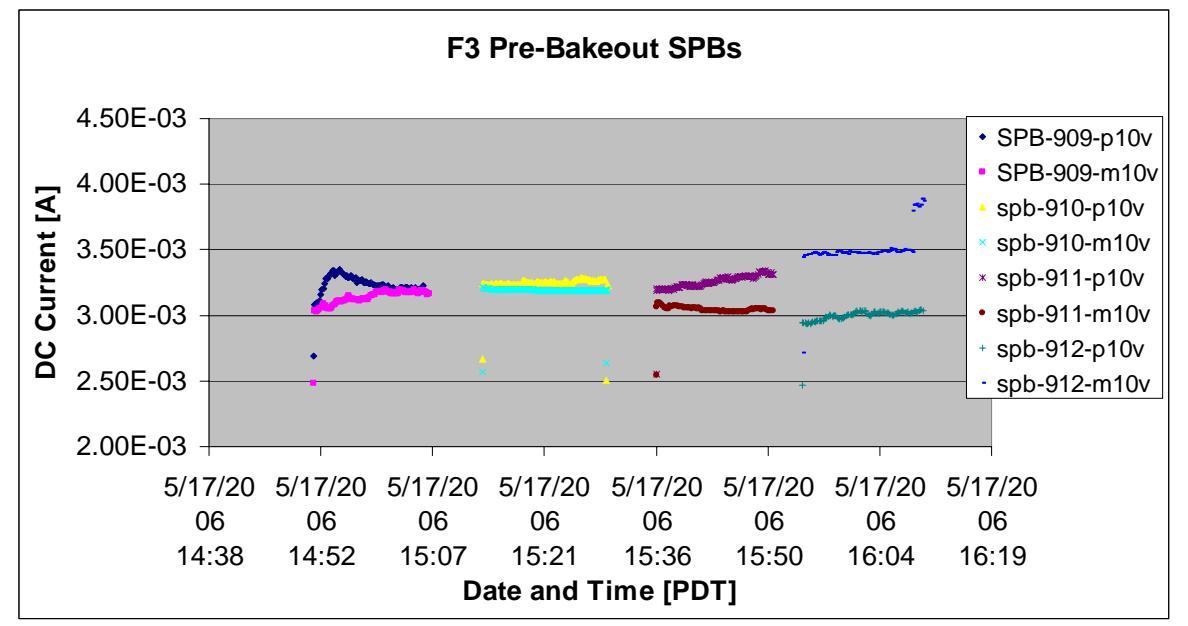
Figure 1: Short-Duration Test

X- and Y-axis pairs of SPBs were turned on separately, with the other axis being replaced with a static load simulator (33-kohm||0.1 uF on each supply to ground) – it was found that the current consumption was still higher and trending upward on the axis with real SPB and preamp loads, while on the other, the current consumption was stable, and somewhat lower, indicating that the source of the anomalous current consumption lay in the SPB units temselves, rather than in the floating supplies in the LVPS. Short (10-min) duration bench tests of current consumption on all four SPBs were performed, and three of the four SPBs (preamps) showed elevated and unstable current consumption, relative to that observed during board-level acceptance tests (see Figure 1).

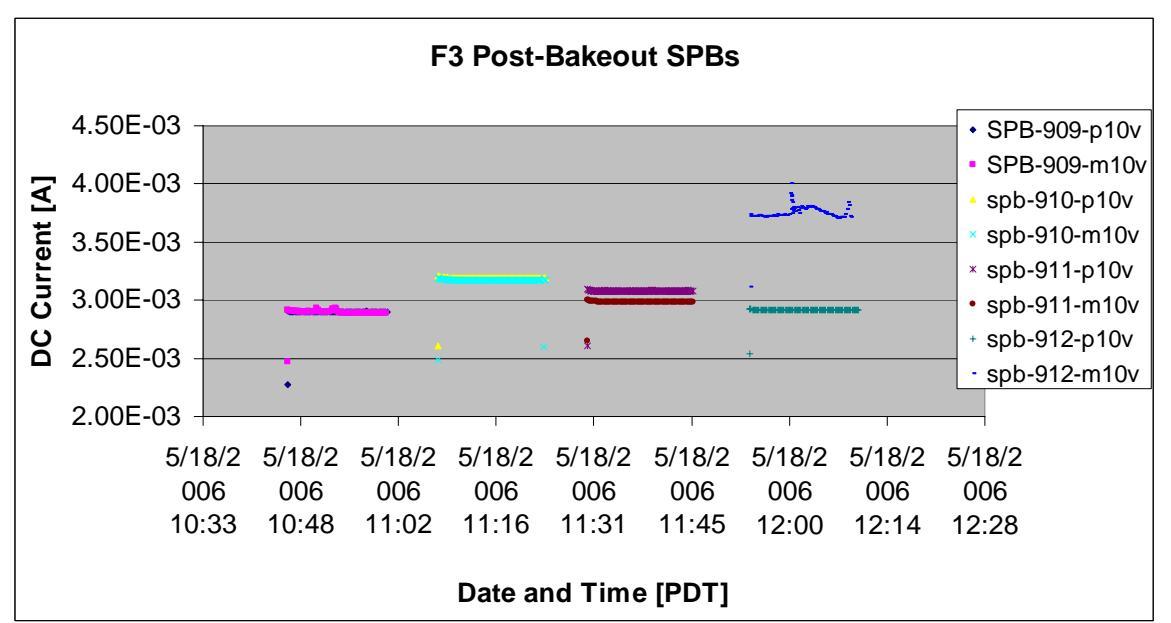
Figure 2: Post-Bakeout Test

All four SPBs were baked out in a vacuum at 65 C for 15 hours, and the short-duration current consumption test repeated to determine if the excess current consumption could be due to either board contamination or the uptake of moisture by the hygroscopic preamp PWB materal (Thermount). Two of the three units that were behaving anomalously were brought back into family by the bakeout, while the third (S/N 912 again) still showed anomalously high current consumption on its positive supply line (see Figure 2).

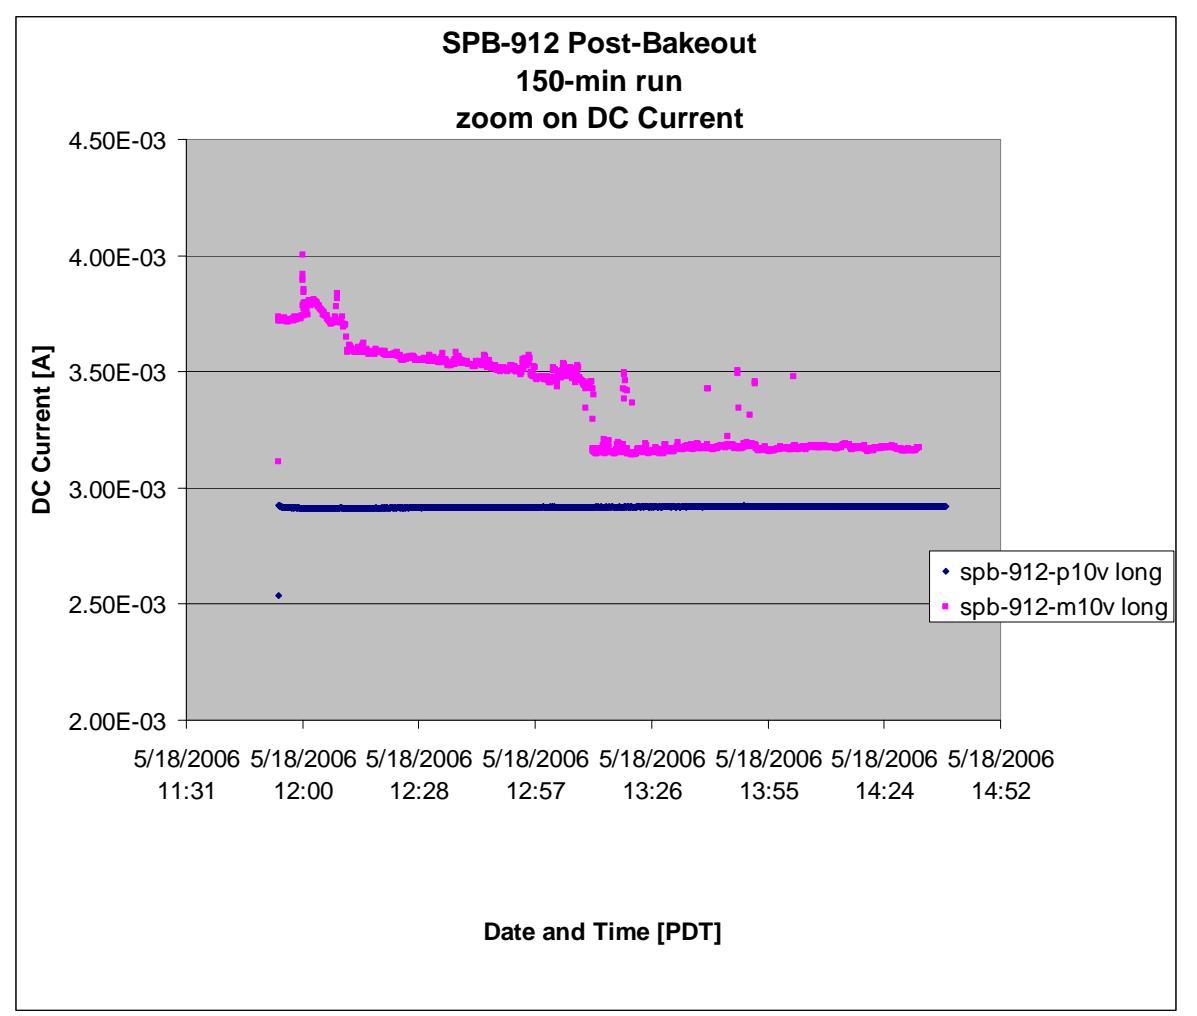
Figure 3: SPB-912, 150-Minute Run

Two long-duration (150-minute and 15-hour) current consumption tests were performed on S/N 912 to establish if the current consumed would stabilize (see Figures 3 and 4). While still noisy, the current consumed stayed within the 3.5 to 4.0 mA range throughout these tests, demonstrating that the unit, while consumping anomalously, would not exceed the \geq = 6-mA limit on the floating supply that would feed it in flight. In addition, the SHIELD (ground) connection of the SPB preamp was monitored during the overnight run in order. As is clear from the plot, the excess current consumption arises from leakage from the positive supply line to the shield, most likely through the same power supply bypass capacitors that were the culprits on P1 (see PFR-096 for details).

As was noted in the Resolution section of PFR-096, while significant in a fractional sense (20-30%), the excess current consumption only amounts to a few mA, and does not significantly impact the IDPU or SC power budgets, nor does it pose a significant risk to the LVPS, and so no invasive corrective action will be performed on the four preamps in question.
