PFR-228 Title:F4 FGM Harness shorted to Boom		
Assembly : Instruments	SubAssembly : FGM	
Component : FGM Harness	Units Affected: Units fixed:	
Originator: Michael Ludlam		
Organization: SSL	Date: 29 September 2006	
Phone: 510-642-7732	Email : mludlam@ssl.berkeley.edu	
<b>Failure Occurred During (Check one</b> $\sqrt{)}$		
x Functional test $\Box$ Qualification test $\Box$ S/C Integration $\Box$ Launch operations $\Box$ Other		
Environment when failure occurred:		
x Ambient	□ Shock □ Acoustic	
Thermal Vacuum	$\Box$ Thermal-Vacuum $\Box$ EMI/EMC	
Problem Description

## Problem/Failure Report THM\_PFR\_228

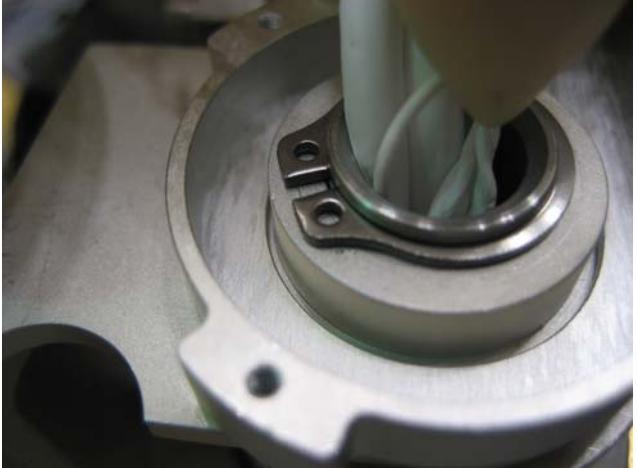
A check out of the harness was carried out which looked nominal, followed by a further CPT. The data still had a problem in the X-axis. A more thorough debugging of the harness wiring found the +x sense (pin 9) of the boom shoulder to sensor harness was connected to spacecraft structure ground. The harness was unplugged from the shoulder and the bend in the harness going into the boom was gently straightened, this caused the connection from pin 9 to structure to change from 2 Ohms to about 400 Ohms.

The boom was inspected by Paul Turin and Yvette Irwin and the cause traced back to the top of the boom shoulder. Indentations were seen in the sense twisted unshielded wire and the short was seen to be intermittent as the harness was moved around in the boom shoulder.

The twisted pairs were individually wrapped in kapton tape and a Teflon tape wrap was put around the harness bundle to protect it from future wear. The other probes were inspected for similar damage but none was seen. However this re-work was carried out on all probes as a precaution. A FGM CPT was run on each probe with an similar problem appearing on F4 Z axis. The F4 boom harness was re-inspected and the Teflon tape was found not to be completely wrapped around the whole harness bundle. This rework was repeated as seen in the photos below and harness wire isolation was checked while the boom was deployed and re-stowed. A CPT was then run on the FGM successfully. This PFR is closed.
