PFR- 26 Title: Sensor Door Axle/Mount Failure

Assembly : THM-AXB-FLT-006 (F3 L)	SubAssembly : THM-AXB-MEC-050-14
	THM-AXB-MEC-050-15
Component : Sensor Door Axle/Mount	
Originator: Rob Duck	Organization: Space Sciences Lab
Phone : 510 643 9234	Email : rduck@ssl.berkeley.edu

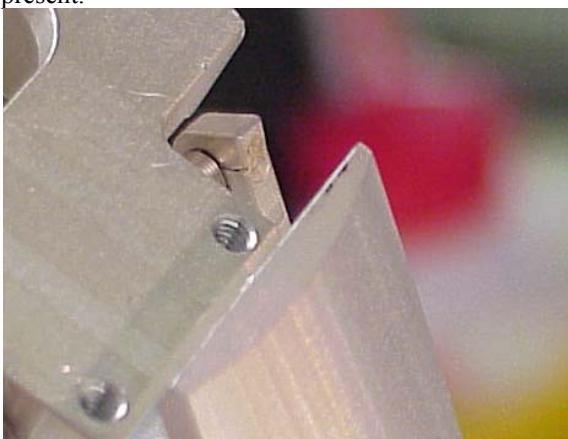
Figure 1. Crack in Door Mount

The boom was inspected visually to determine the cause. The part of the mount that showed the fracture was where the door axles contacted the mount, figure 1. The inside of the mount had the fracture and the axle was bowed up slightly, figure 2. The axle received significant stress resulting in yielding. This stress was also transmitted to the inside of the axle hole on the mount, placing the hole under significant tensile loading and ultimately leading to the yield and fracture of the metal. Thus there was a significant force placed on the door, pulling the axle and causing the failure. There are two possible factors that may have contributed to the failure of the door mounts and axles.

New door mount assemblies have been built for THM-AXB-FLT-006 and will be assembled onto the boom. Since they are the last assembly added during the original boom assembly, the main DAD, stacer, preamp, and cable assemblies are unaffected. FLT-006 has already completed all environmental testing however, it will go through an additional functional deployment to verify that the new 050 sensor door assemblies function properly, a workmanship vibration, and then a final functional deployment test to verify proper operation, at which point the boom testing will be considered complete and ready for science calibration and Suite I&T.

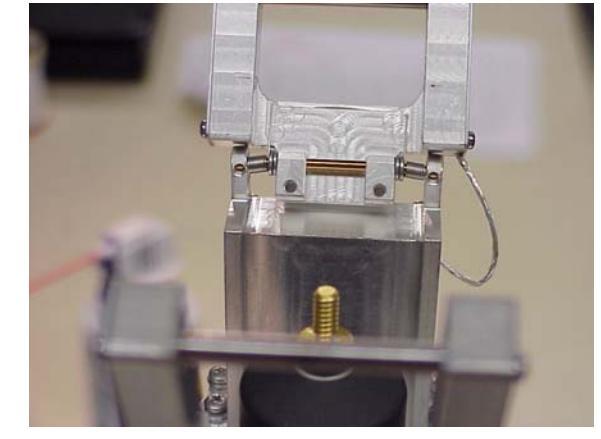
Figure 2. Bent Door Axle

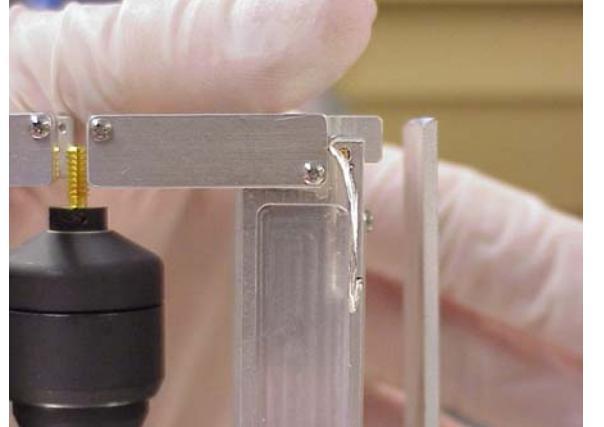
Figure 3. Door post relative to door (latch removed)

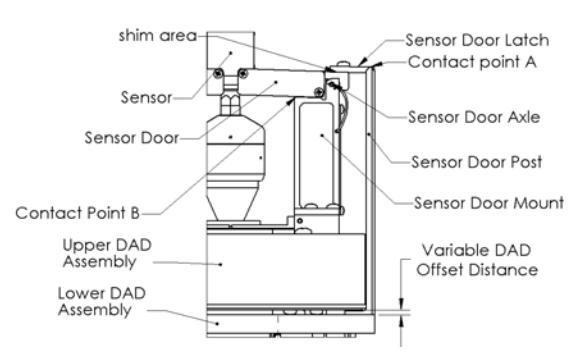
Figure 4. Stowed boom front view.

The second source of stress on the door comes from the door latches that are screwed on the doors in the final assembly step of the stow process. As the latches are screwed down, they are hooked onto the sensor door posts (contact point A, figure 4) which apply upward pressure on the latches causing the doors to close down on the mount (contact point B, figure 4). They are designed to apply slight pressure on the door thus holding it in position and keep the sensor from deploying. Both the sensor door mounts and sensor door posts are rigidly fastened to two separate subassemblies of the DAD ("Deploy Assistance Device"). Each of these assemblies, the upper and lower DAD respectively, is spring loaded. Slight variations in the spring forces due to spring manufacturing will result in different offsets between the upper and lower DAD assemblies when compressed and stowed. This creates variations in the position of the door mounts from boom to boom. The higher the door post relative to the door mount, the greater the interference between the latch and post, and the more stress will be produced on the axle when the latches are screwed down. Thus one boom may produce more stress on the axle in its stowed configuration than another.

In the case of the FLT-006 boom, the combination of the offsets between the mount and post was large enough to generate significant post/latch interference. This interference and the possible impact generated from the errant stowing of the actuator resulted in additional forces at contact points A & B, figure 4. The axle and mount were force to bear this stress and failed.

The interference issue can be removed through shimming the latches. This procedure step was reviewed in the ETU build however during the first several flight builds, it was determined that shimming was not needed as the tolerance build ups were small enough. FLT-006 was the first boom where stack up may have been significant. A straight edge will be placed from sensor door post to sensor door post with the sensor doors in the closed position. The gap between the post and the top of the door will be measured and calibrated for the proper spacing. If this spacing is too large, shims will be placed between the sensor door and sensor door latches, reducing the interference between the latch and post, see shim location on figure 4. The stow procedure will be updated to reflect this new step. This final stow procedure step will be adopted on all booms moving forward.
