PFR-096 Title: EFI Y Current Monitor Unstable				
Assembly : EFI		SubAssembly : Y	SubAssembly : Y-Axis	
Component :	Unknown	Units Affected:	Units fixed:	
Originator: John Bonnell		x o o o o o	x o o o o o	
Organization: UCBSSL		Date: 16 Sep 2005	Date: 16 Sep 2005	
Phone:510-642-0852		Email :jbonnell@	Email :jbonnell@ssl.berkeley.edu	
Failure Occuri	red During (Check on	ie √)		
X Functional test \Box Qualification test \Box S/C Integration \Box Launch operations \Box Other (Flight Assy)			ns 🗆 Other (Flight Assy)	
Environment v	vhen failure occurred	:		
XAmbient	Vibration	□ Shock	Acoustic	
□ Thermal	Vacuum	Thermal-Vacuum	□ EMI/EMC	
Problem Description

Problem/Failure Report THM_PFR_096

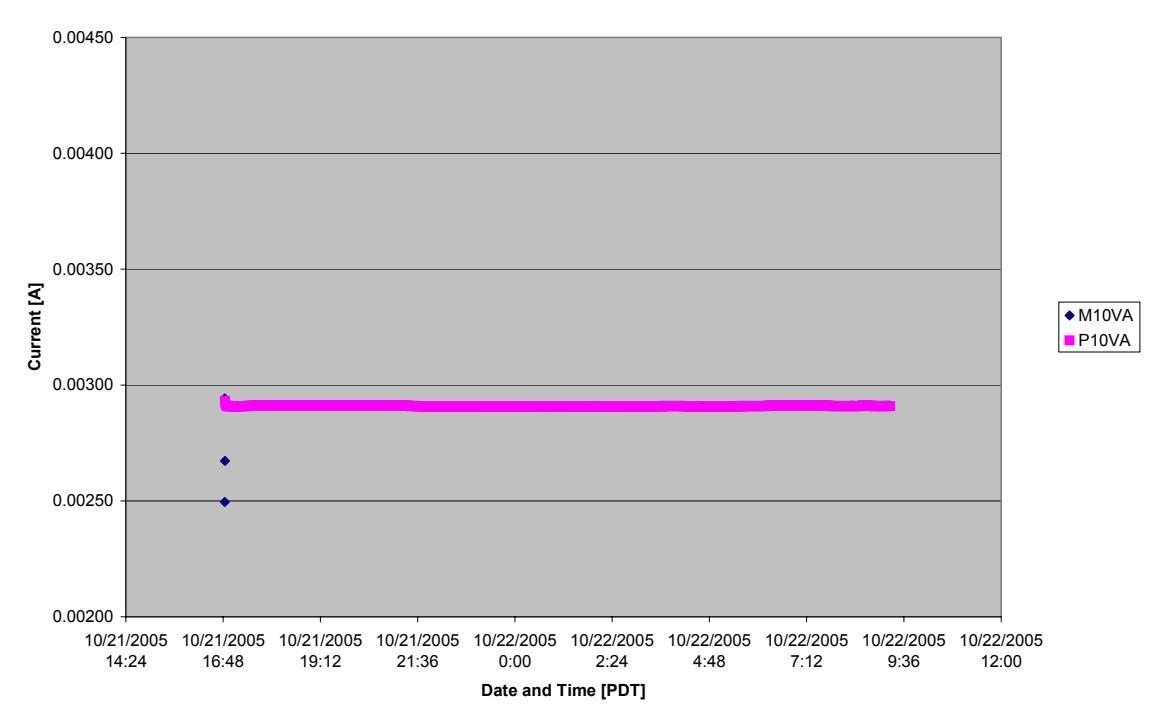
PRE-023, Config-003

C1A and C1B were replaced on PRE-023, and packaged for possible DPA (see *Assembly_Repair-Rework_THM_rev4-thm-efi-pre-023-revA.doc* for details of the rework procedure); the 15-hour current consumption test was run, and it was found that current consumption was nominal and very stable, with less than a 0.01-mA (10-uA) change in current consumption over the test, and no evidence of the sporadic increases in current consumption observed with the original pair of tantalum bypass capacitors in the circuit. Charts showing the current consumption test results are included in Appendix A below.

"PRE-023, RW1, CONFIG-003" is a 15-hour current consumption test using the PRE-023 unit with replacement tantalum bypass capacitors. Input and output termination is as in the preceeding CONFIG-003 tests.
