PFR-088 Title: IDPU Mechanical Board Fouling Issue

Assembly : IDPU	SubAssembly : DAP/BEB	
Component : Board Shields	Units Affected:	Units fixed:
Originator: Michael Ludlam	<input checked="" type="checkbox"/> <input checked="" type="checkbox"/> <input checked="" type="checkbox"/> <input checked="" type="checkbox"/> <input checked="" type="checkbox"/> <input checked="" type="checkbox"/>	<input checked="" type="checkbox"/> <input checked="" type="checkbox"/> <input checked="" type="checkbox"/> <input checked="" type="checkbox"/> <input checked="" type="checkbox"/> <input checked="" type="checkbox"/>
Organization: UCB	Date: 3/AUG/05	
Phone: 510 642 7732	Email : mludlam@ssl.berkeley.edu

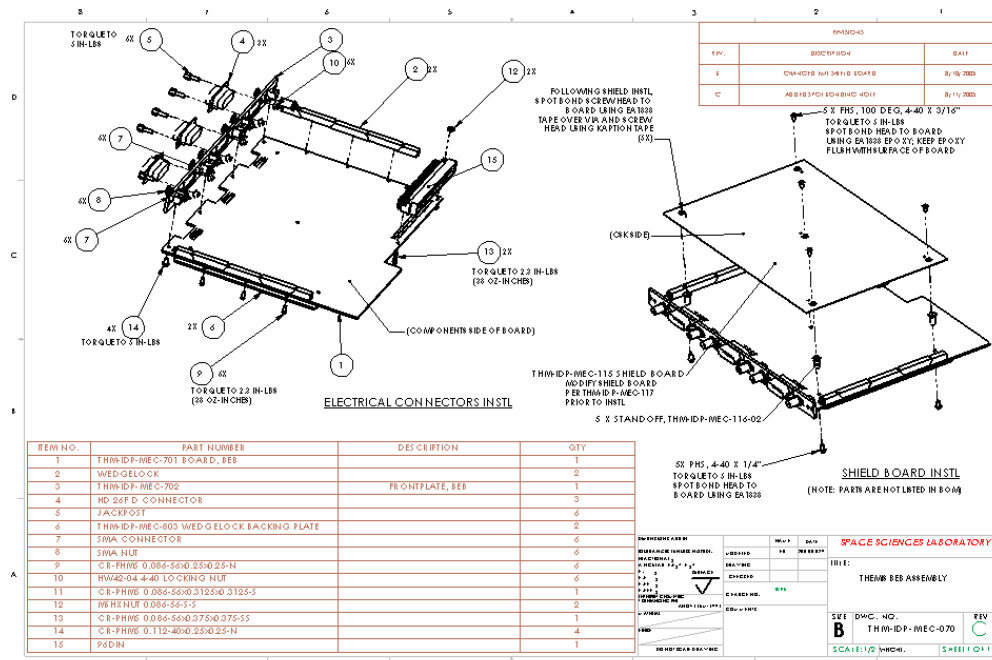
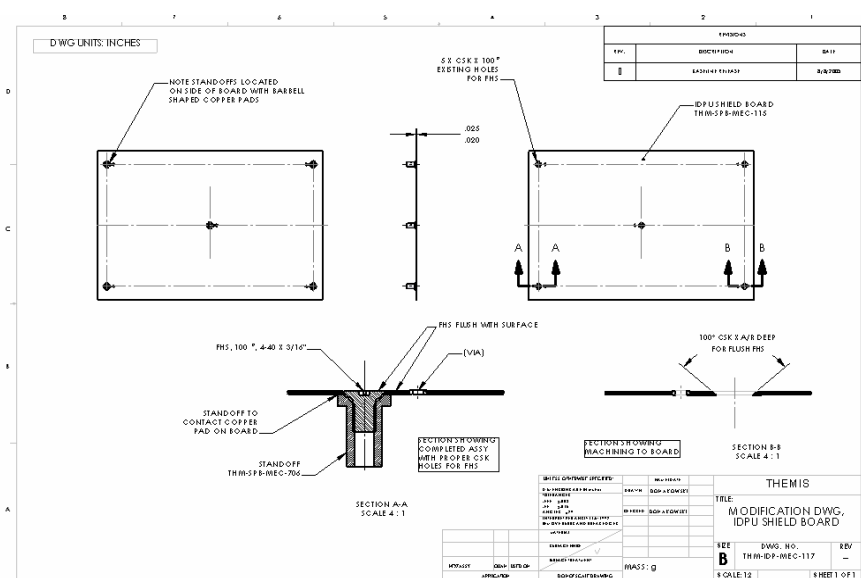
The problem was traced to the shorting of capacitors on the underneath of the DAP board to the board shield below it (BEB). The IDPU box was disassembled and the BEB shield was examined. It was seen to have a number of scratches where components on the DAP board were touching up against the shield. It was verified with the DAP team that no damage could be done to the DAP board in this instance and the PCB engineer confirmed that the current draw through the PCB for this time was within limits for the FETs used. The LVPS has over current protection and survives this kind of incident.
